## Uniform Mitigation Verification Inspection Form

| Inspection Date: 08/17/2026 | | |
| Address: Bldg # 2537 Oakleaf Ln (Units A, B, C, D) | | Home Phone: |

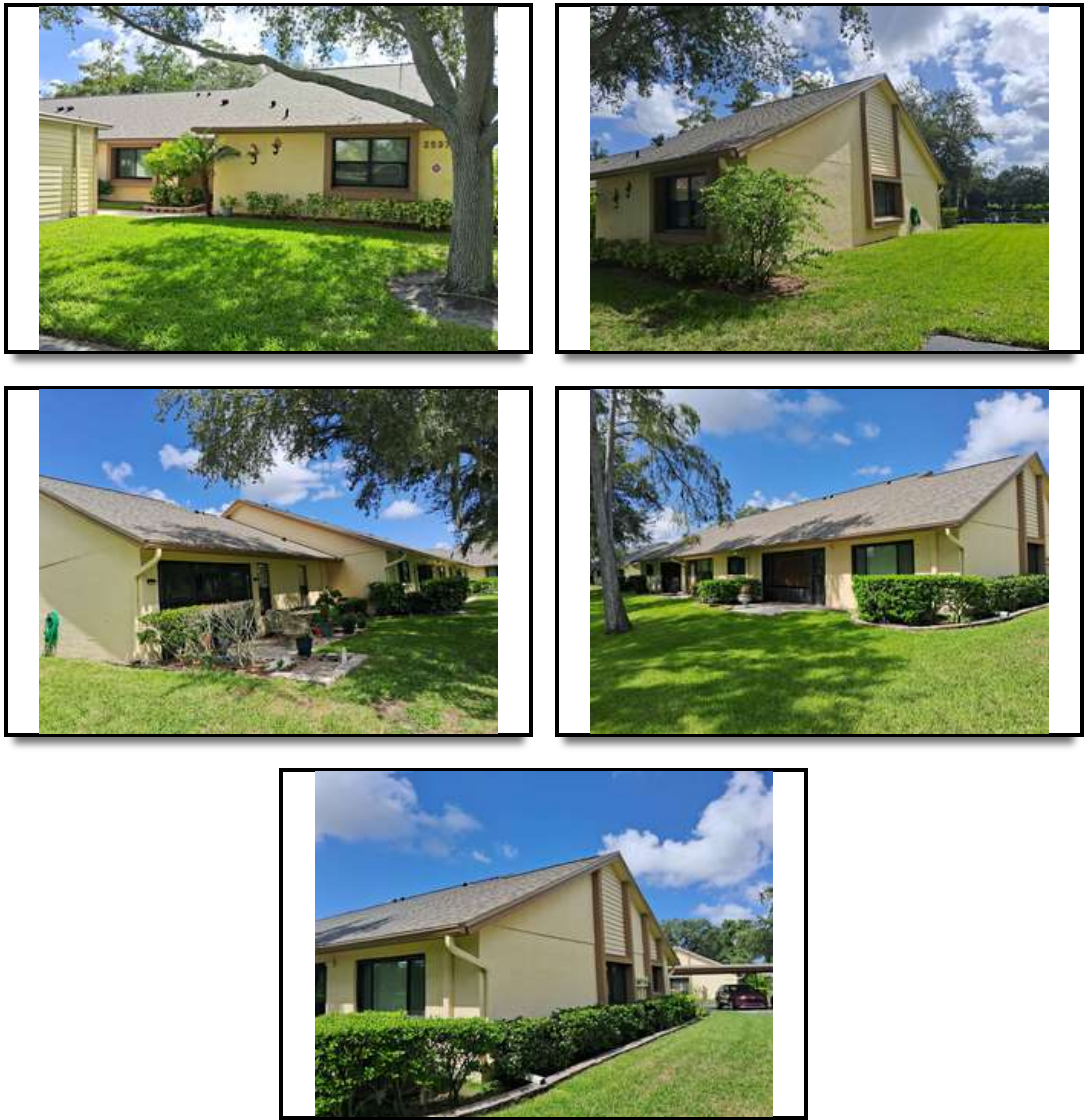
1. Dwelling Elevations

| Year of Home: 1979 | # of Stories: 1 | Email: lessueprest@hotmail.com, |

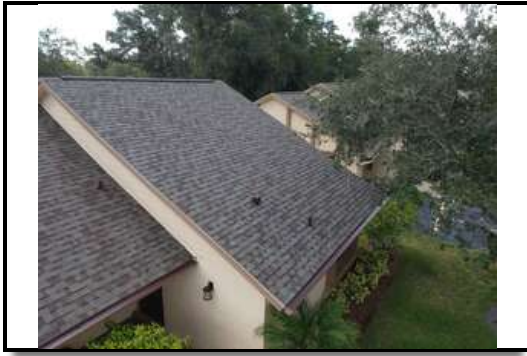
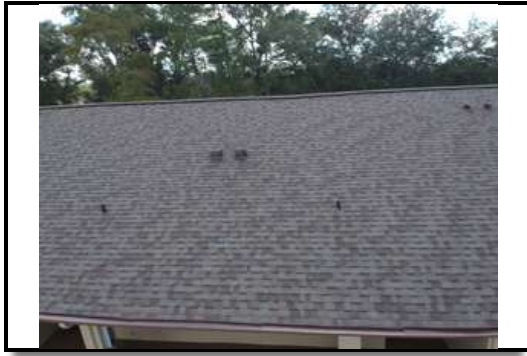
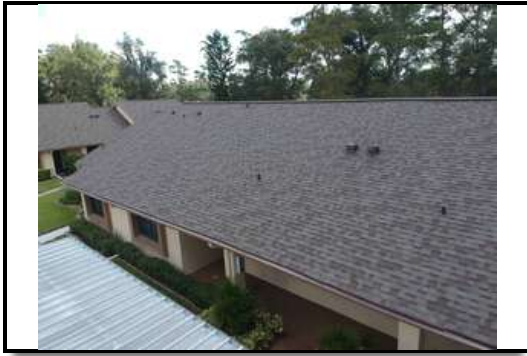
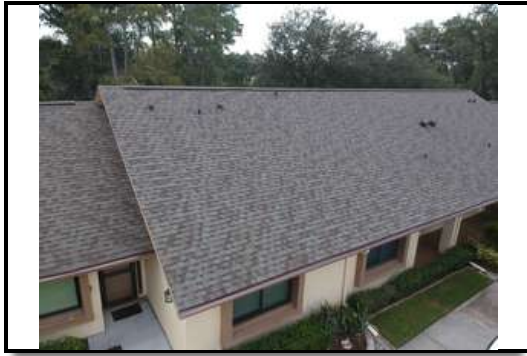
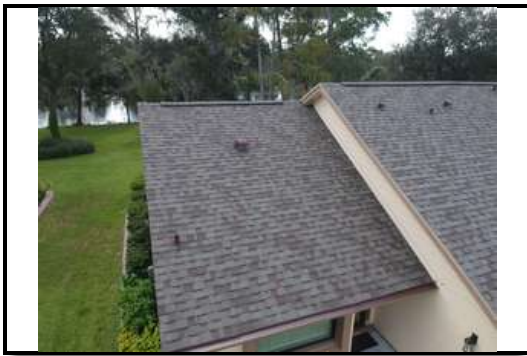
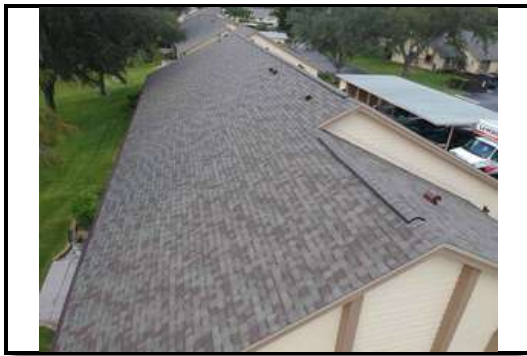
2. Roof Slopes/Coverings

- Roof Slope:** For single-family homes with multiple slopes, indicate the slope that is at least two thirds of the main roof area when determining greater than or equal to 6:12, OR less than 6:12.  
☒ Greater than or equal to ( $\geq 6:12$ )  
☐ Less than ( $< 6:12$ )

| 4.1 Roof Covering Type | Permit Application Date | FBC or MDC Product Approval # | Year of Original Installation or Replacement | No Information Provided for Compliance |
|---|---|---|---|---|
| <input checked="" type="checkbox"/> Asphalt/Fiberglass Shingle | 6/8/2026 | | 2026 | <input type="checkbox"/> |

- ☒ A. All roof coverings listed above meet the FBC with a FBC or Miami-Dade Product Approval listing current at the time of installation OR have a roofing permit application date on or after 3/1/02 OR the roof is original and built in 2004 or later.
- ☐ B. All roof coverings have a Miami-Dade Product Approval listing current at time of installation OR (for the HVHZ only) a roofing permit application after 9/1/1994 and before 3/1/2002 OR the roof is original and built in 1997 or later.
- ☐ C. One or more roof coverings do not meet the requirements of Answer "A" or "B.";
- ☐ D. No roof coverings meet the requirements of Answer "A" or "B."

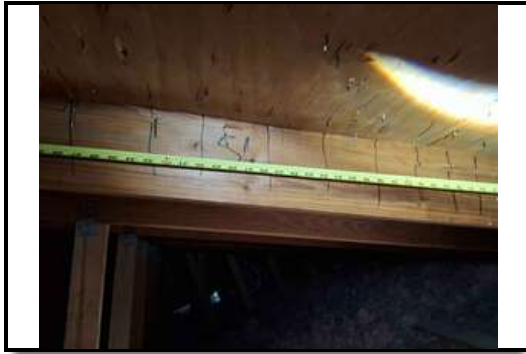
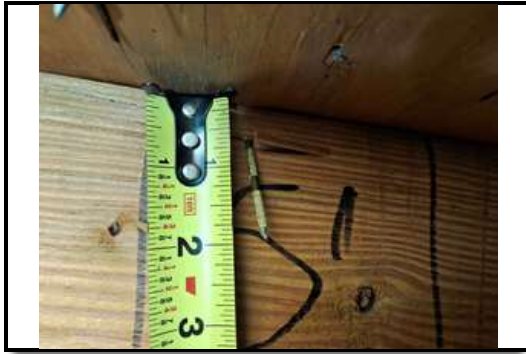
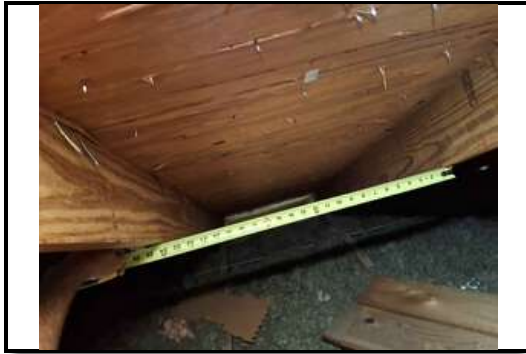
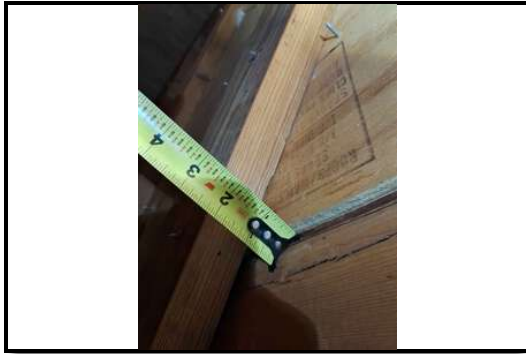
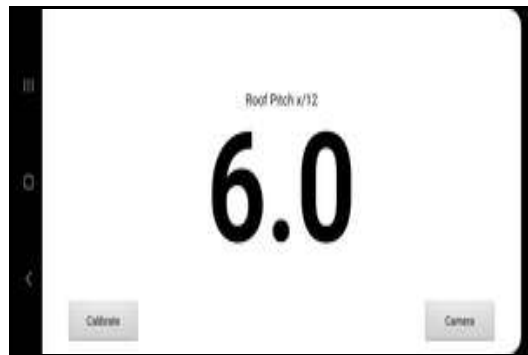
### 4. Roof Deck Attachment

- ☒ C. Plywood/OSB roof sheathing with a minimum thickness of 7/16" attached to the roof truss/rafter (spaced a maximum of 24" o.c.) by 8d common nails spaced a maximum of 6" in the field. **OR** Dimensional lumber/Tongue & Groove decking with a minimum of 2 nails per board (or 1 nail per board if each board is equal to or less than 6" in width). **OR** Any system of screws, nails, adhesives, other deck fastening system or truss/rafter spacing that is shown to have an equivalent or greater resistance than 8d common nails spaced a maximum of 6" in the field (max 24" truss/rafter spacing) or has a mean ultimate uplift resistance of at least 182 psf.

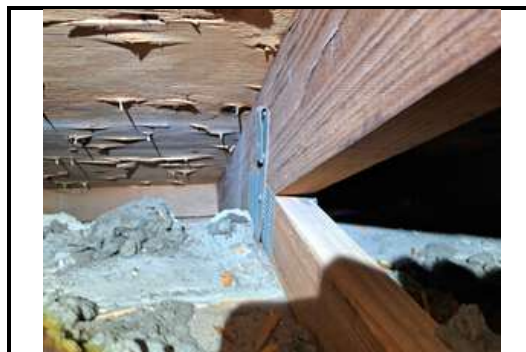
## 5. Roof to Wall Attachment

- ☒ 1. Metal connectors secured to truss/rafter with a minimum of three (3) nails, and attached to the side and/or bottom of the wall framing top plate, or embedded into the bond beam, with less than 1/2" gap from the blocking or truss/rafter, and blocked no more than 1 1/2" from the truss/rafter, and free of visible severe corrosion, **OR**

- ☒ B. Clips:
- ☒ Metal connectors that do not wrap over the truss/rafter, **OR**
  - ☐ Metal connectors with a minimum of one (1) strap that wraps over the truss/rafter and does not meet the nail position requirements of C or D but is secured with a minimum of three (3) nails, **OR**

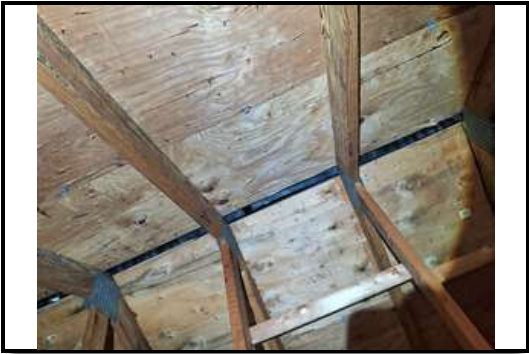
## 6. Sealed Roof Deck/Secondary Water Resistance (SWR)

- ☒ A. Sealed Roof Deck (also called SWR)
    - ☒ Fully adhered polymer-modified bitumen roofing underlayment complying with ASTM D1970.
    - ☐ Tape over roof deck seams with felt or synthetic. (A minimum 3.75-inch-wide (95 mm) strip of self-adhering polymer-modified bitumen membrane complying with ASTM D1970 or self-adhering flexible flashing tape complying with AAMA 711, Level 3 [for exposure up to 176°F (80°C)]).
