## Uniform Mitigation Verification Inspection Form

| Owner Name: Village on the Green Condominium II Association Inc. | | Contact Person: Les Prest / Jennifer Noland |
| Address: Bldg # 2555 Oakleaf Ln (Units A, B, C) | | Home Phone: |

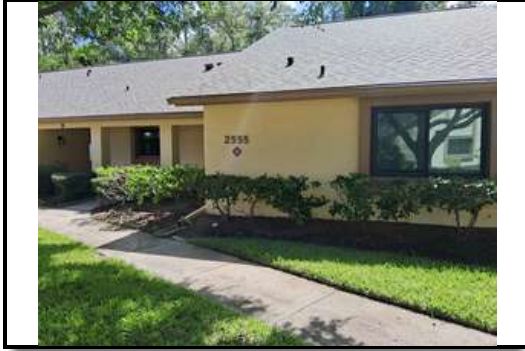
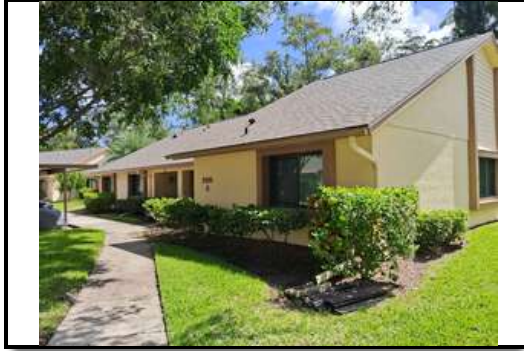
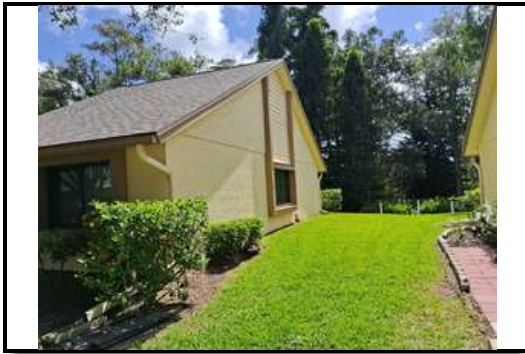
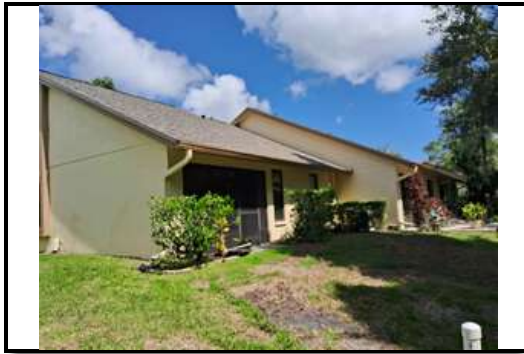
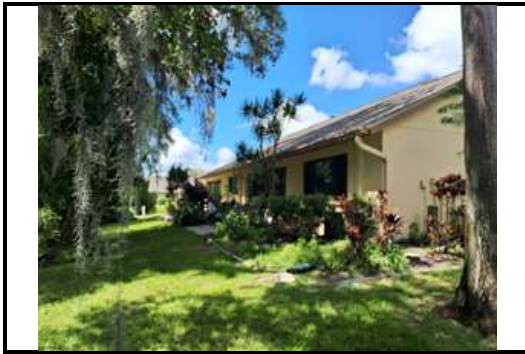
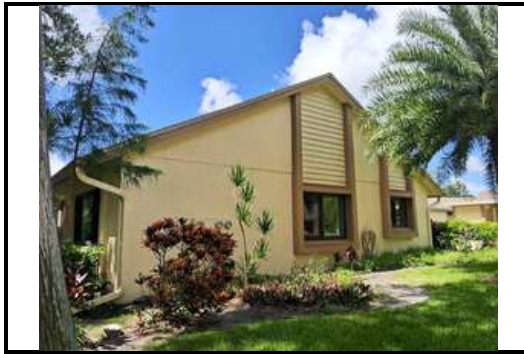
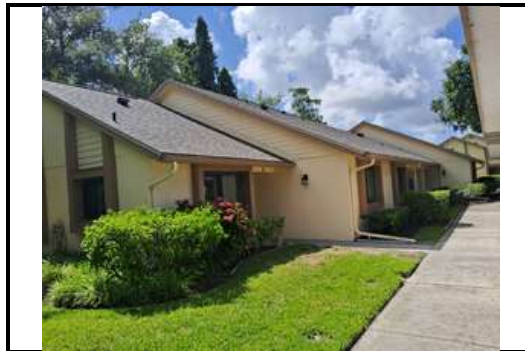
#### 3. Dwelling Elevations

##### Dwelling Elevations

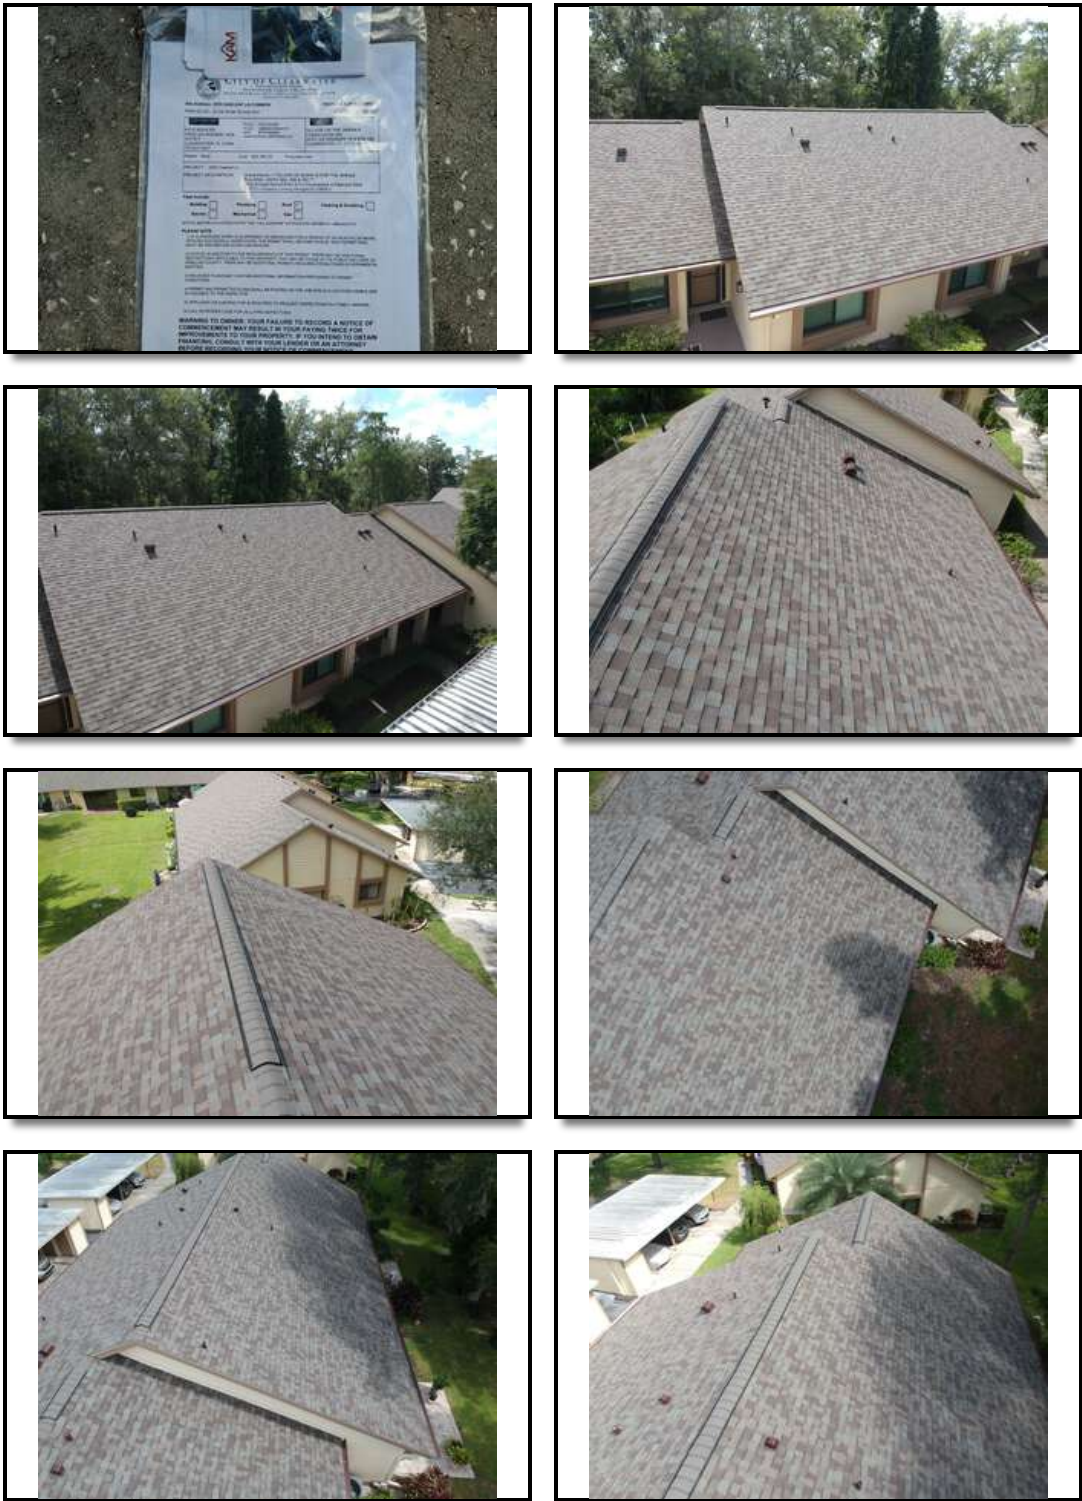
4. Roof Slopes/Coverings

3. **Roof Slope:** For single-family homes with multiple slopes, indicate the slope that is at least two thirds of the main roof area when determining greater than or equal to 6:12, OR less than 6:12.
  - ☒ Greater than or equal to ( $\geq$  6:12)
  - ☐ Less than ( $<$  6:12)

| 4.1 Roof Covering Type | Permit Application Date | FBC or MDC Product Approval # | Year of Original Installation or Replacement | No Information Provided for Compliance |
|---|---|---|---|---|
| <input checked="" type="checkbox"/> Asphalt/Fiberglass Shingle | 6/8/2026 | | 2026 | <input type="checkbox"/> |

Roof Slopes/Coverings

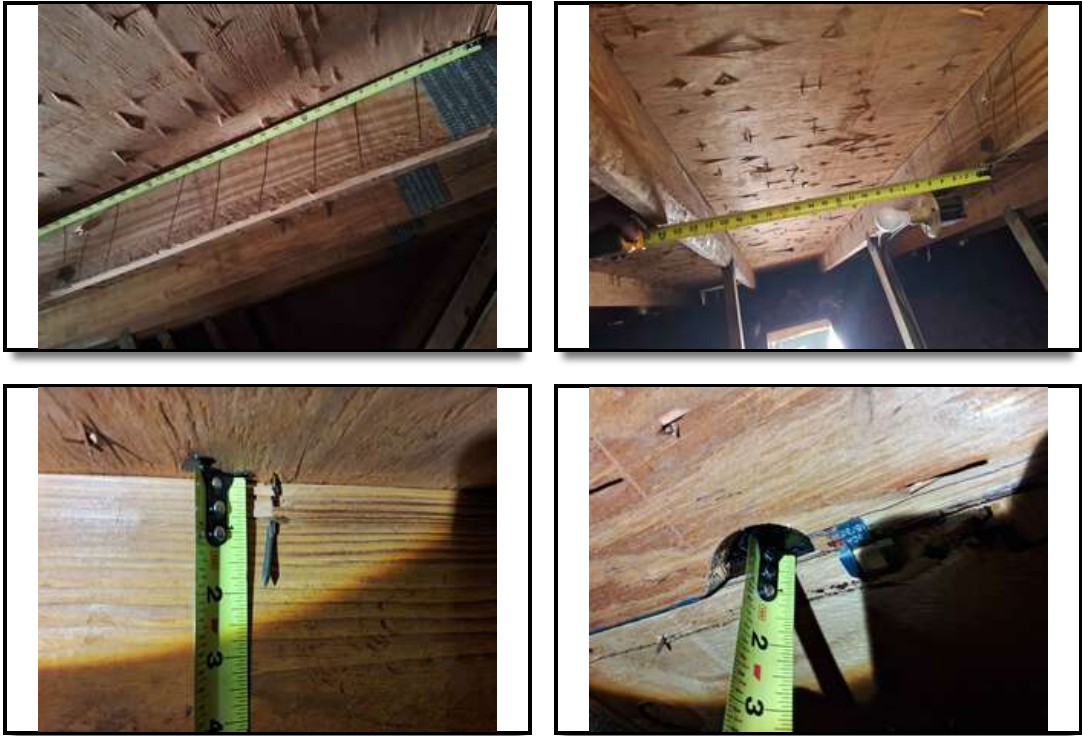
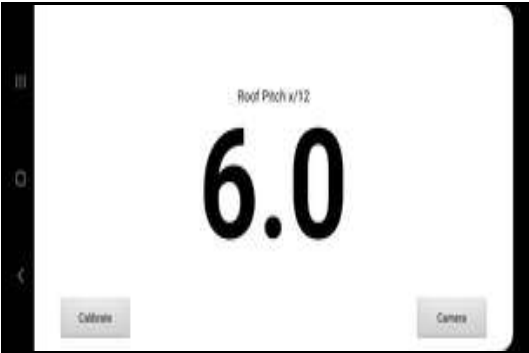
6. Roof Deck Attachment

- ☒ C. Plywood/OSB roof sheathing with a minimum thickness of 7/16" attached to the roof truss/rafter (spaced a maximum of 24" o.c.) by 8d common nails spaced a maximum of 6" in the field. **OR** Dimensional lumber/Tongue & Groove decking with a minimum of 2 nails per board (or 1 nail per board if each board is equal to or less than 6" in width). **OR** Any system of screws, nails, adhesives, other deck fastening system or truss/rafter spacing that is shown to have an equivalent or greater resistance than 8d common nails spaced a maximum of 6" in the field (max 24" truss/rafter spacing) or has a mean ultimate uplift resistance of at least 182 psf.

Roof Deck Attachment

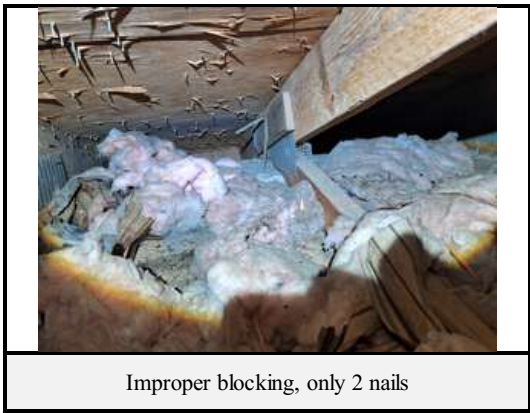
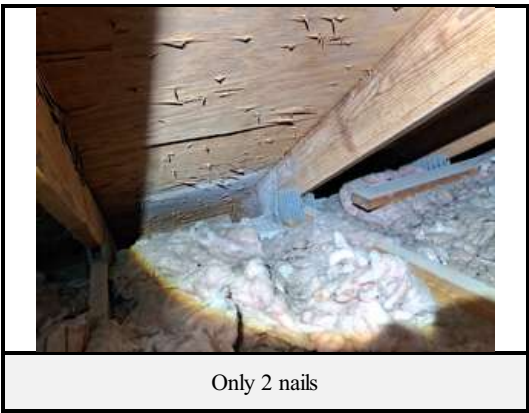
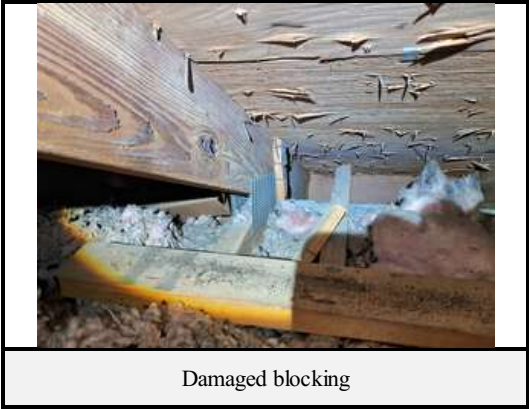
7. Roof to Wall Attachment

- ☒ A. Toenails:
  - ☐ Truss/rafter anchored to top plate of wall using nails driven at an angle through the truss/rafter and attached to the top plate of the wall, **OR**
  - ☒ Metal connectors or structural fasteners that are not installed as intended do not meet the minimal conditions or requirements of B, C, or D, **OR**
  - ☐ Other connection method documented to provide a substantiated wind allowable uplift capacity of 185 lbs. or greater.

Roof to Wall Attachment

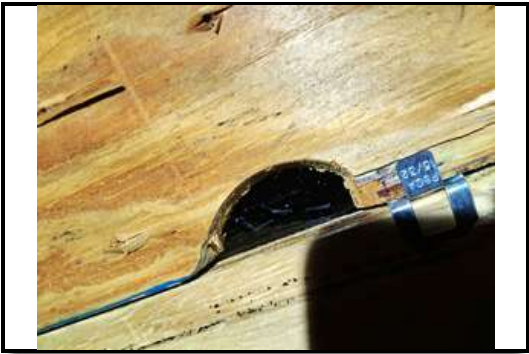
8. Sealed Roof Deck/Secondary Water Resistance (SWR)

- ☒ A. Sealed Roof Deck (also called SWR)
    - ☒ Fully adhered polymer-modified bitumen roofing underlayment complying with ASTM D1970.
    - ☐ Tape over roof deck seams with felt or synthetic. (A minimum 3.75-inch-wide (95 mm) strip of self-adhering polymer-modified bitumen membrane complying with ASTM D1970 or self-adhering flexible flashing tape complying with AAMA 711, Level 3 [for exposure up to 176°F (80°C)]).

Sealed Roof Deck/Secondary Water Resistance (SWR)
