## Uniform Mitigation Verification Inspection Form

| Inspection Date: 08/17/2026 | | |
| Owner Name: Village on the Green Condominium II Association Inc. | | Contact Person: Les Prest / Jennifer Noland |
| Address: Bldg # 2561 Oakleaf Ln (Units A, B, C) | | Home Phone: |

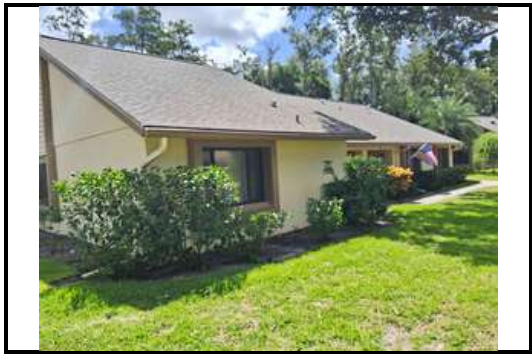
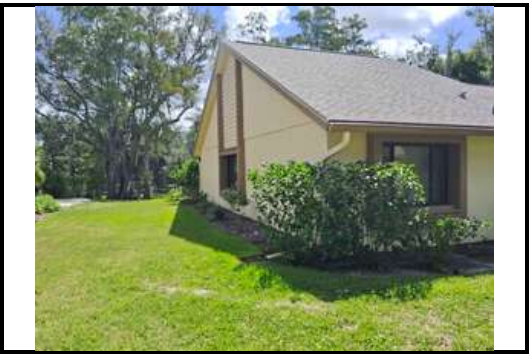
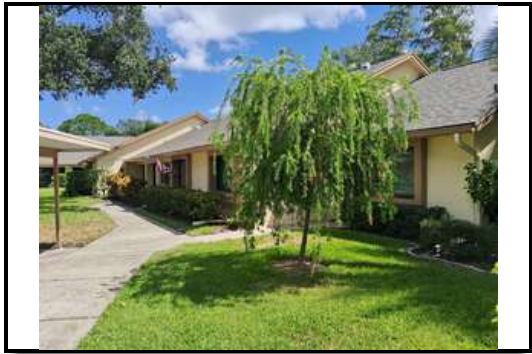
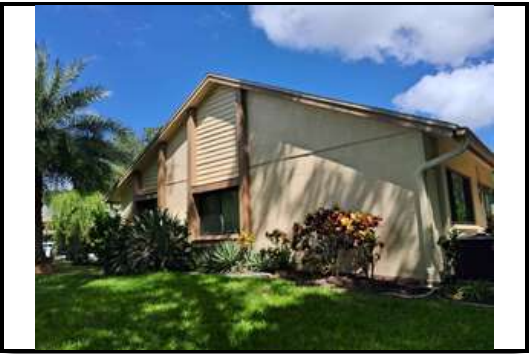
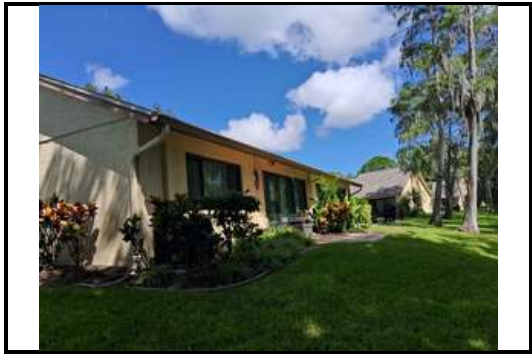
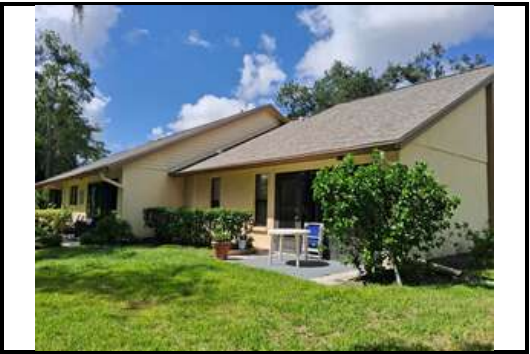
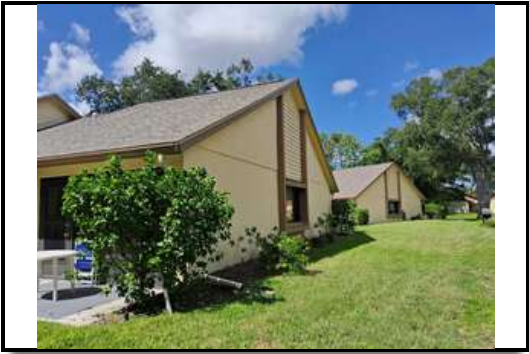
1. Dwelling Elevations

Dwelling Elevations

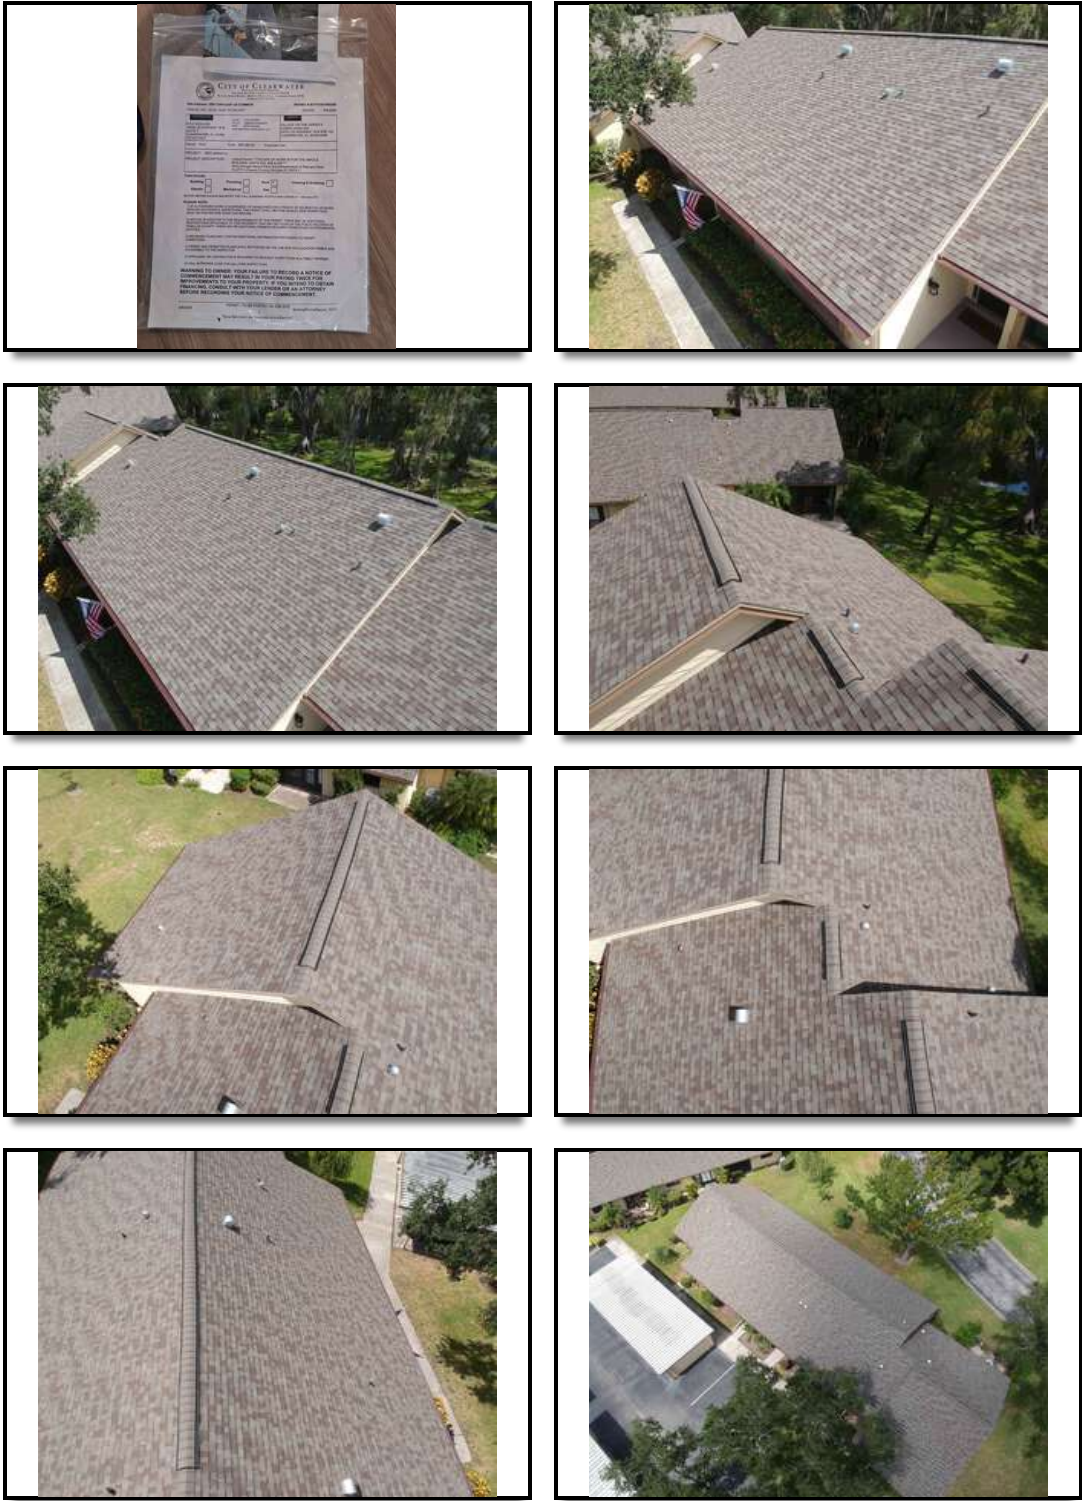
2. Roof Slopes/Coverings

3. **Roof Slope:** For single-family homes with multiple slopes, indicate the slope that is at least two thirds of the main roof area when determining greater than or equal to 6:12, OR less than 6:12.
  - ☒ Greater than or equal to ( $\geq$  6:12)
  - ☐ Less than ( $<$  6:12)

| 4.1 Roof Covering Type | Permit Application Date | FBC or MDC Product Approval # | Year of Original Installation or Replacement | No Information Provided for Compliance |
|---|---|---|---|---|
| <input checked="" type="checkbox"/> Asphalt/Fiberglass Shingle | 6/8/2026 | | 2026 | <input type="checkbox"/> |

Roof Slopes/Coverings

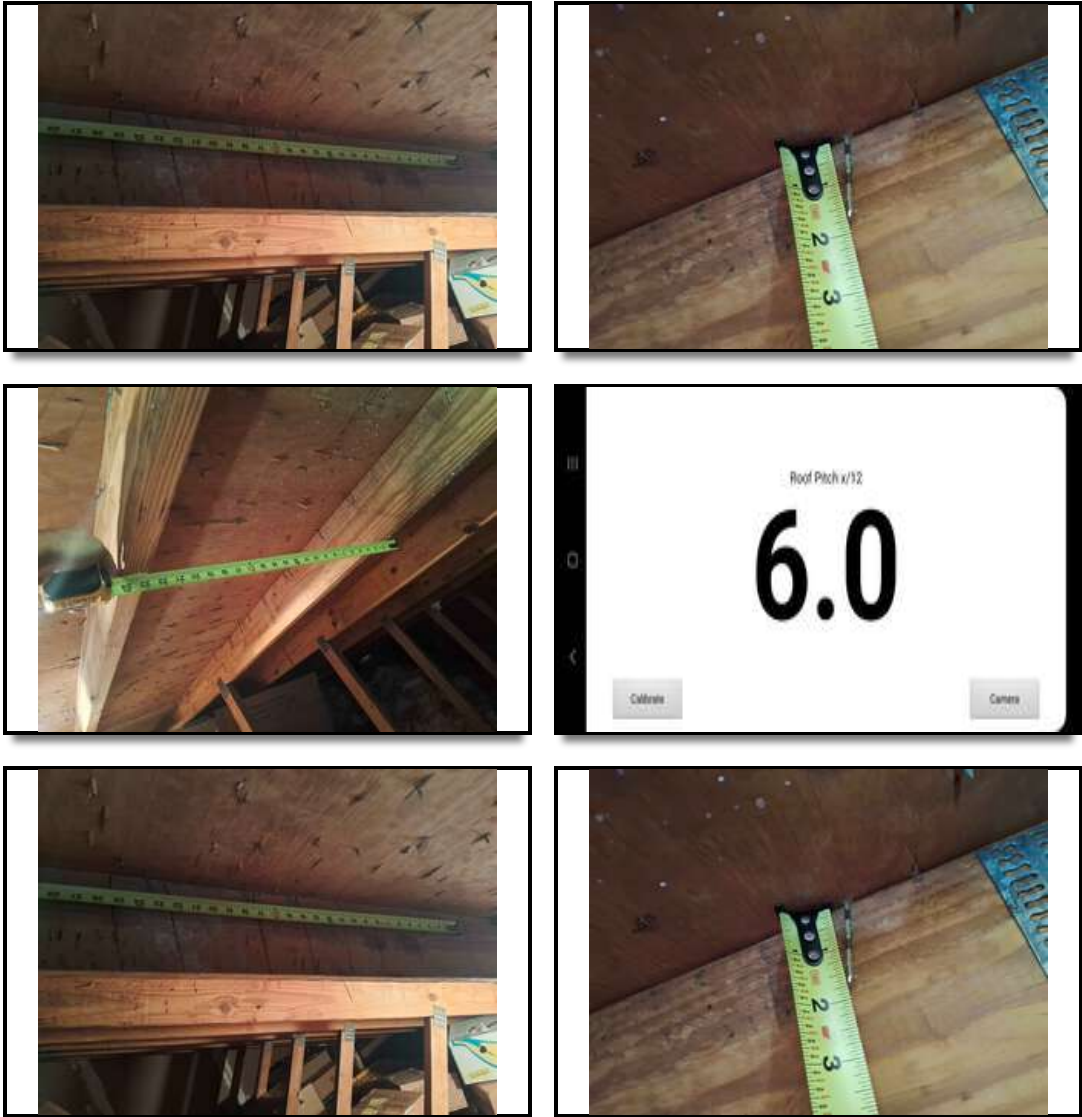
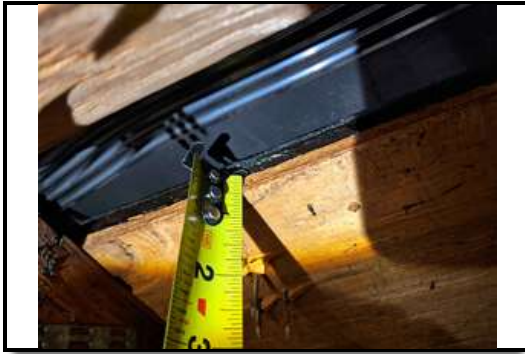
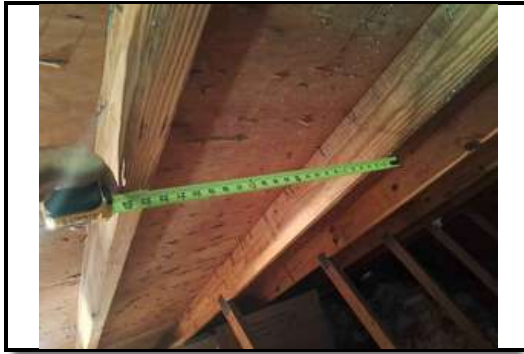
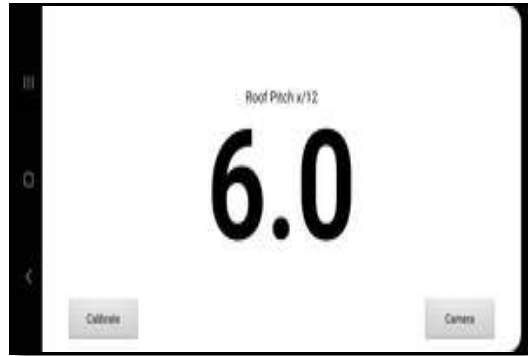
4. Roof Deck Attachment

- ☒ C. Plywood/OSB roof sheathing with a minimum thickness of 7/16" attached to the roof truss/rafter (spaced a maximum of 24" o.c.) by 8d common nails spaced a maximum of 6" in the field. **OR** Dimensional lumber/Tongue & Groove decking with a minimum of 2 nails per board (or 1 nail per board if each board is equal to or less than 6" in width). **OR** Any system of screws, nails, adhesives, other deck fastening system or truss/rafter spacing that is shown to have an equivalent or greater resistance than 8d common nails spaced a maximum of 6" in the field (max 24" truss/rafter spacing) or has a mean ultimate uplift resistance of at least 182 psf.

Roof Deck Attachment

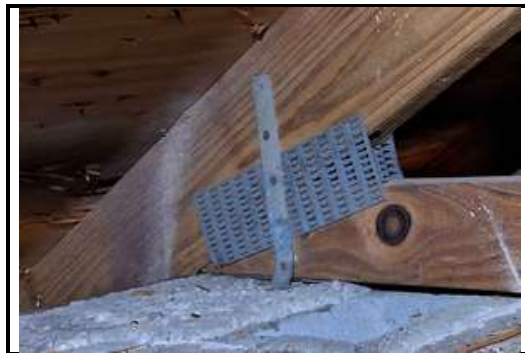
#### 5. Roof to Wall Attachment

- ☒ 1. Metal connectors secured to truss/rafter with a minimum of three (3) nails, and attached to the side and/or bottom of the wall framing top plate, or embedded into the bond beam, with less than 1/2" gap from the blocking or truss/rafter, and blocked no more than 1 1/2" from the truss/rafter, and free of visible severe corrosion, **OR**

- ☒ B. Clips:
- ☒ Metal connectors that do not wrap over the truss/rafter, **OR**
  - ☐ Metal connectors with a minimum of one (1) strap that wraps over the truss/rafter and does not meet the nail position requirements of C or D but is secured with a minimum of three (3) nails, **OR**

Roof to Wall Attachment

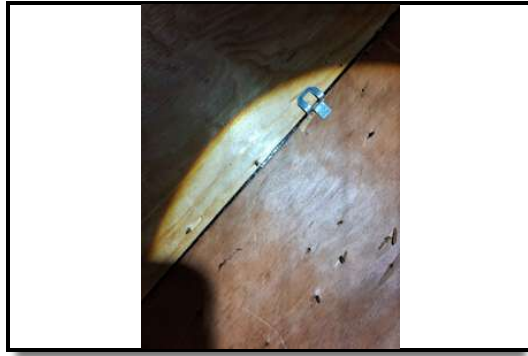
#### 6. Sealed Roof Deck/Secondary Water Resistance (SWR)

- ☒ A. Sealed Roof Deck (also called SWR)
    - ☒ Fully adhered polymer-modified bitumen roofing underlayment complying with ASTM D1970.
    - ☐ Tape over roof deck seams with felt or synthetic. (A minimum 3.75-inch-wide (95 mm) strip of self-adhering polymer-modified bitumen membrane complying with ASTM D1970 or self-adhering flexible flashing tape complying with AAMA 711, Level 3 [for exposure up to 176°F (80°C)]).

Sealed Roof Deck/Secondary Water Resistance (SWR)
