## Uniform Mitigation Verification Inspection Form

| Owner Name: Village on the Green Condominium II Association Inc. | | Contact Person: Les Prest / Jennifer Noland |
| Address: Bldg # 2567 Oakleaf Ln (Units A, B, C, D) | | Home Phone: |
| Year of Home: 1979 | # of Stories: 1 | Email: lessueprest@hotmail.com |

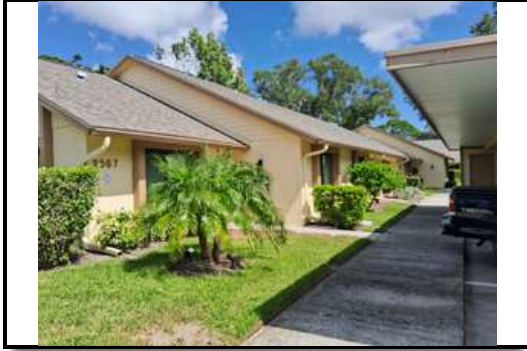
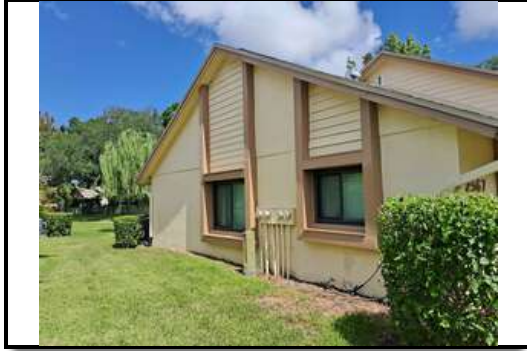
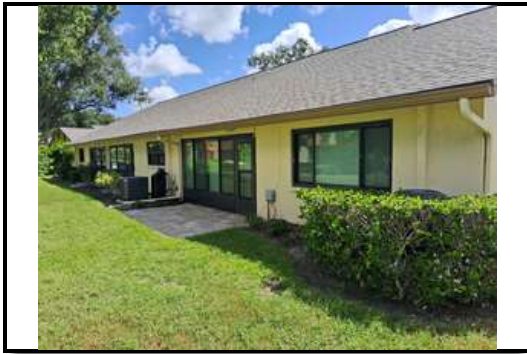
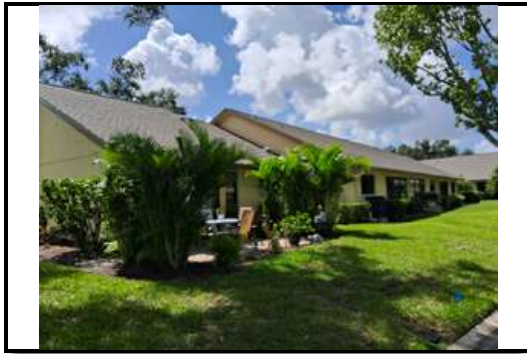
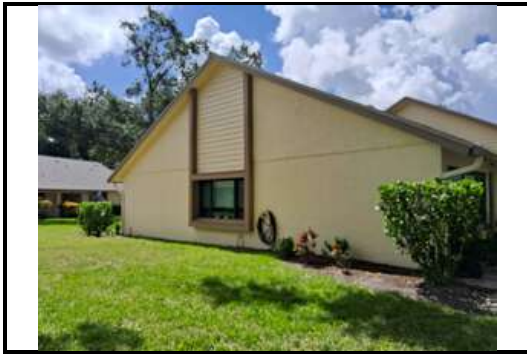
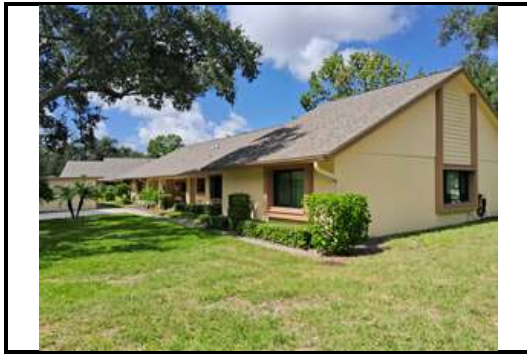
#### 2. Dwelling Elevations

Dwelling Elevations

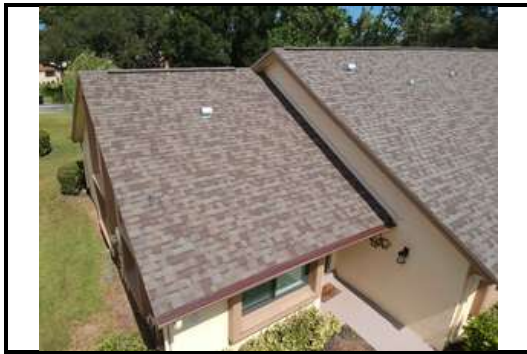
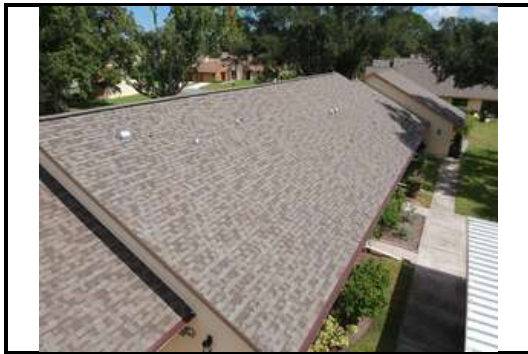
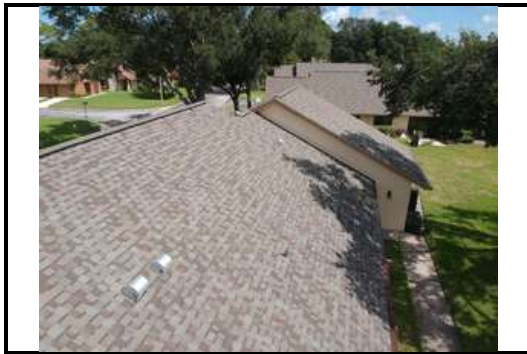
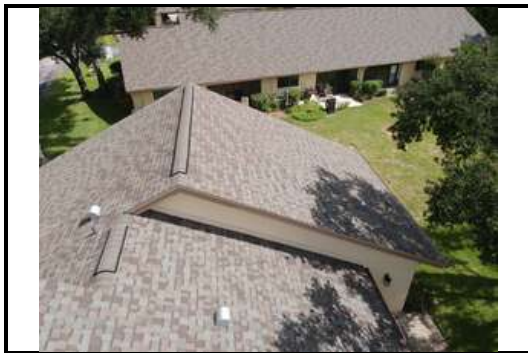
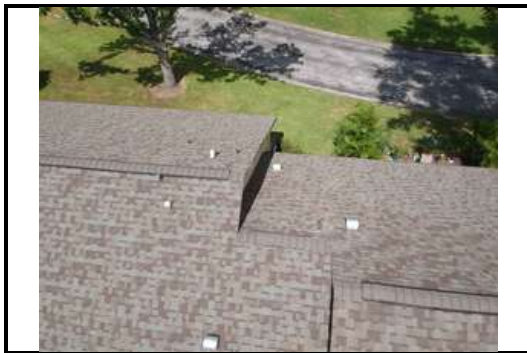
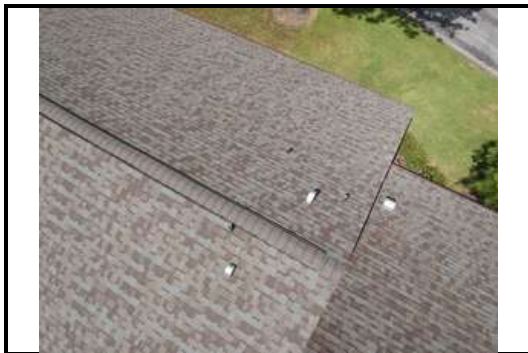
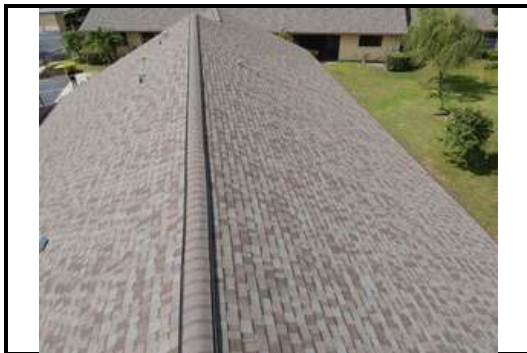
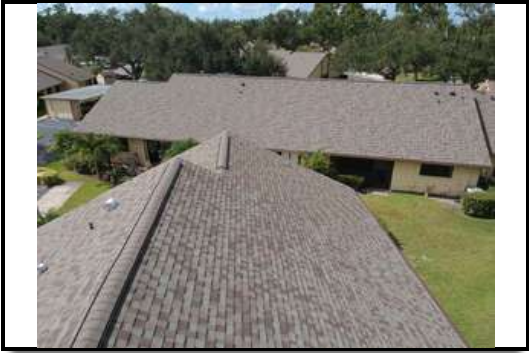
#### 3. Roof Slopes/Coverings

| 4.1 Roof Covering Type | Permit Application Date | FBC or MDC Product Approval # | Year of Original Installation or Replacement | No Information Provided for Compliance |
|---|---|---|---|---|
| <input checked="" type="checkbox"/> Asphalt/Fiberglass Shingle | 6/8/2026 | | 2026 | <input type="checkbox"/> |

Roof Slopes/Coverings

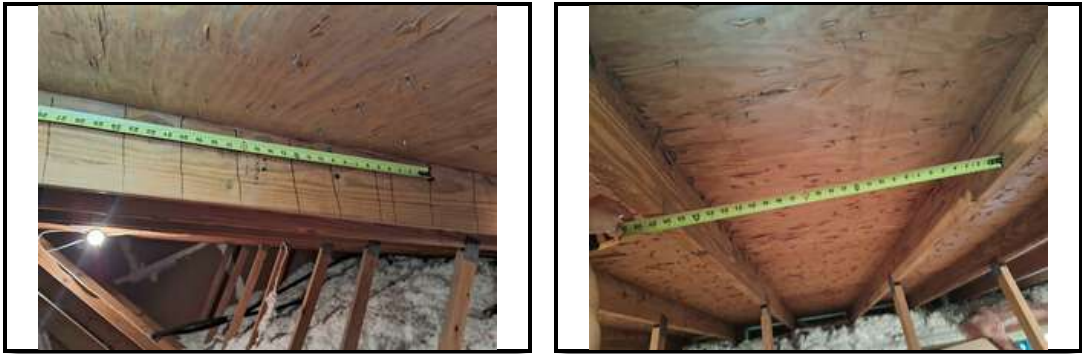
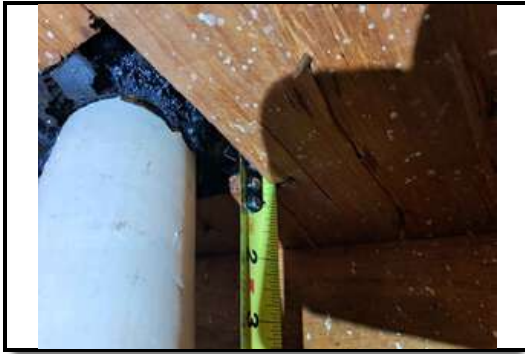
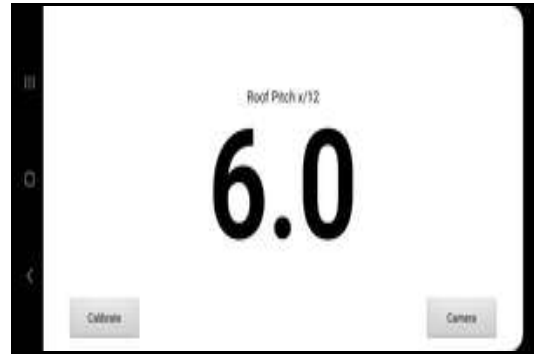
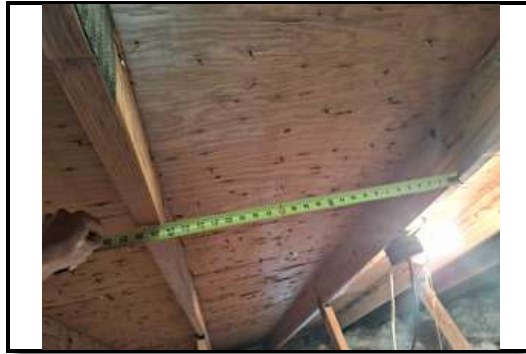
5. Roof Deck Attachment

- ☒ F. Other: truss greater than 24in spacing
- ☐ G. Unknown or unidentified.
- ☐ H. No attic access.

Roof Deck Attachment

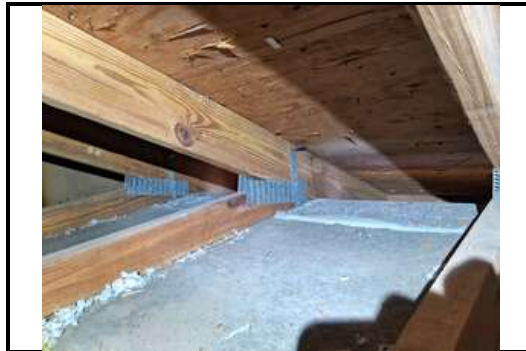
#### 6. Roof to Wall Attachment

- ☒ 1. Metal connectors secured to truss/rafter with a minimum of three (3) nails, and attached to the side and/or bottom of the wall framing top plate, or embedded into the bond beam, with less than 1/2" gap from the blocking or truss/rafter, and blocked no more than 1 1/2" from the truss/rafter, and free of visible severe corrosion, **OR**

- ☒ B. Clips:
- ☒ Metal connectors that do not wrap over the truss/rafter, **OR**
  - ☐ Metal connectors with a minimum of one (1) strap that wraps over the truss/rafter and does not meet the nail position requirements of C or D but is secured with a minimum of three (3) nails, **OR**

Roof to Wall Attachment

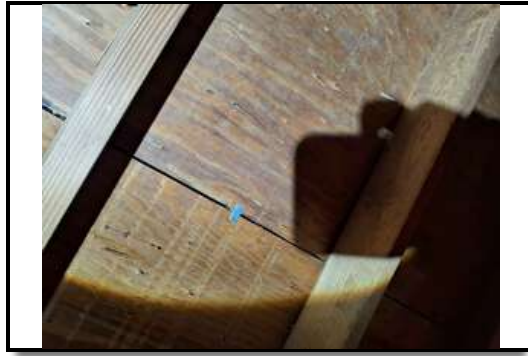
#### 7. Sealed Roof Deck/Secondary Water Resistance (SWR)

- ☒ A. Sealed Roof Deck (also called SWR)
    - ☒ Fully adhered polymer-modified bitumen roofing underlayment complying with ASTM D1970.
    - ☐ Tape over roof deck seams with felt or synthetic. (A minimum 3.75-inch-wide (95 mm) strip of self-adhering polymer-modified bitumen membrane complying with ASTM D1970 or self-adhering flexible flashing tape complying with AAMA 711, Level 3 [for exposure up to 176°F (80°C)]).

Sealed Roof Deck/Secondary Water Resistance (SWR)
