## Uniform Mitigation Verification Inspection Form

| Owner Name: Village on the Green Condominium II Association Inc. | | Contact Person: Les Prest / Jennifer Noland |
| Address: Bldg # 2573 Oakleaf Ln (Units A, B, C, D) | | Home Phone: |
| Year of Home: 1979 | # of Stories: 1 | Email: lessueprest@hotmail.com, |

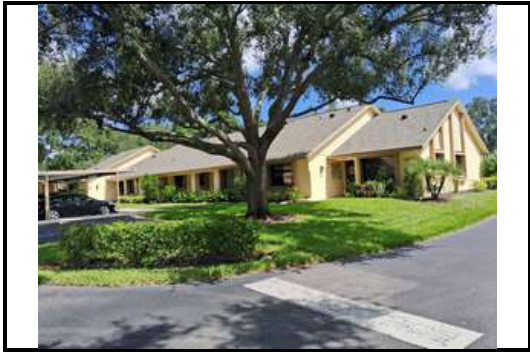
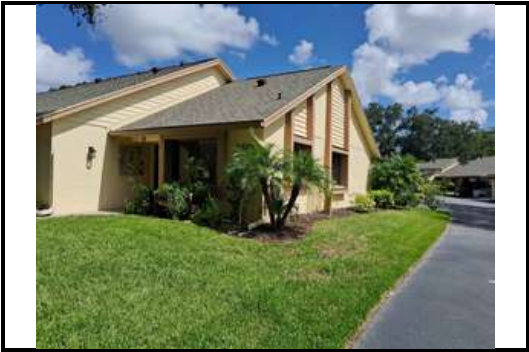
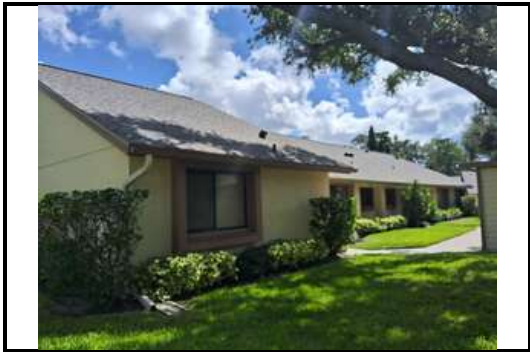
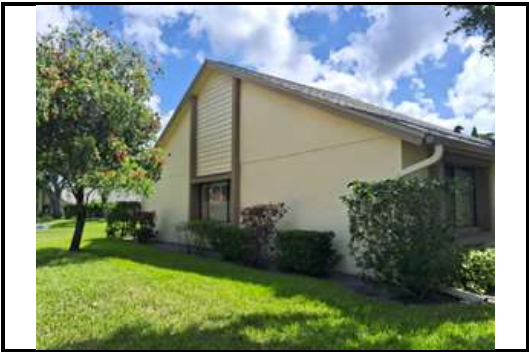
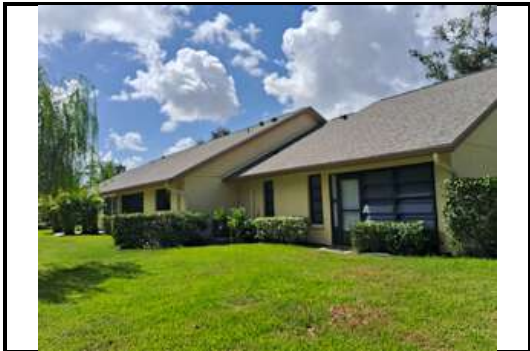
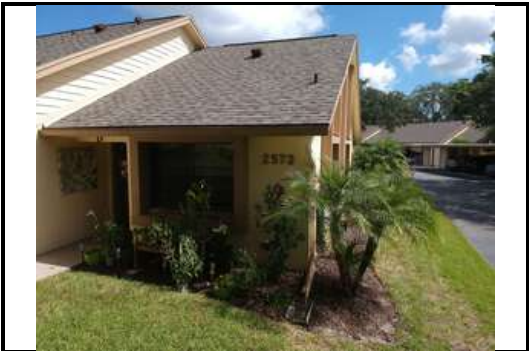
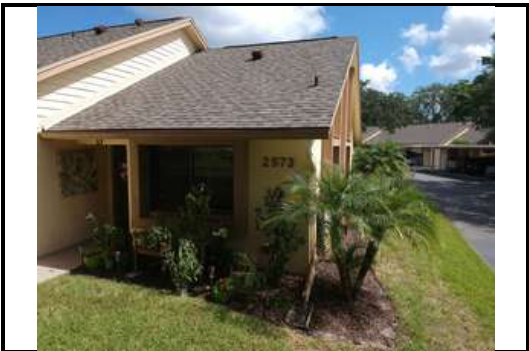
1. Dwelling Elevations

Dwelling Elevations

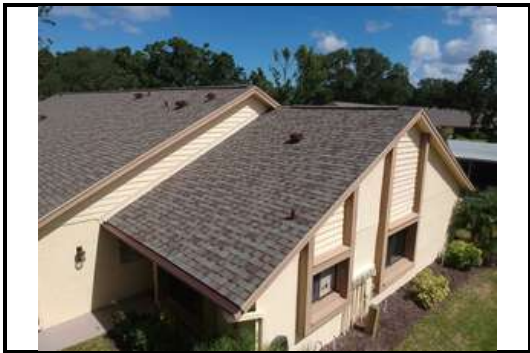
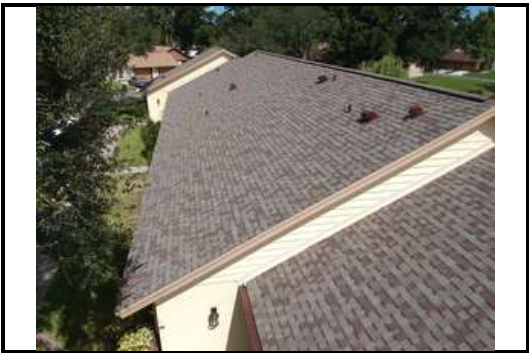
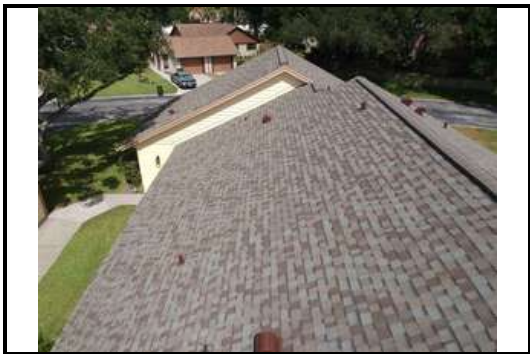
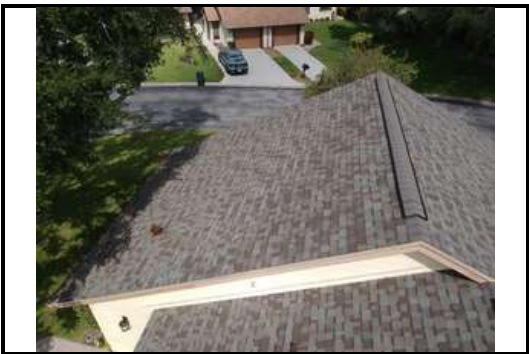
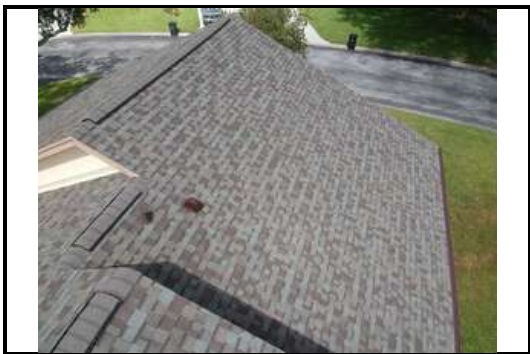
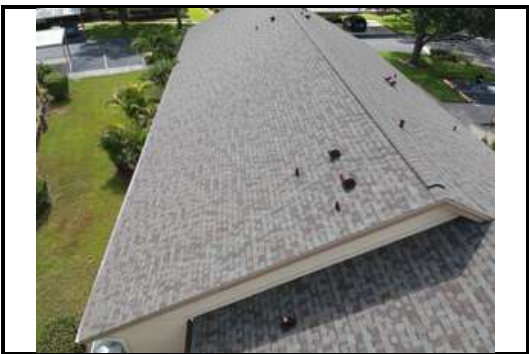
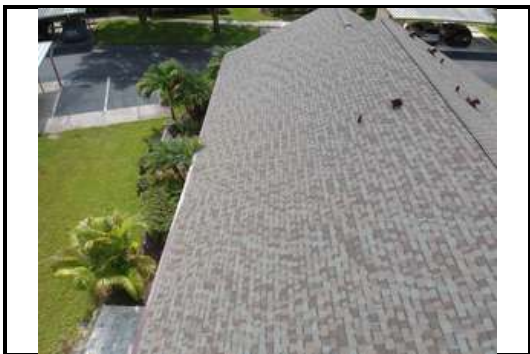
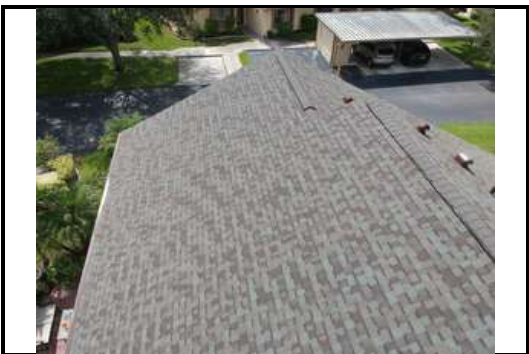
2. Roof Slopes/Coverings

| 4.1 Roof Covering Type | Permit Application Date | FBC or MDC Product Approval # | Year of Original Installation or Replacement | No Information Provided for Compliance |
|---|---|---|---|---|
| <input checked="" type="checkbox"/> Asphalt/Fiberglass Shingle | 6/8/2026 | | 2026 | <input type="checkbox"/> |

Roof Slopes/Coverings

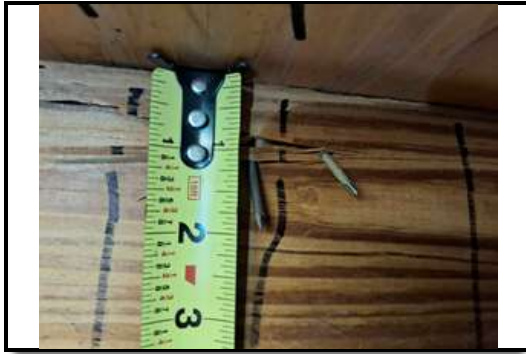
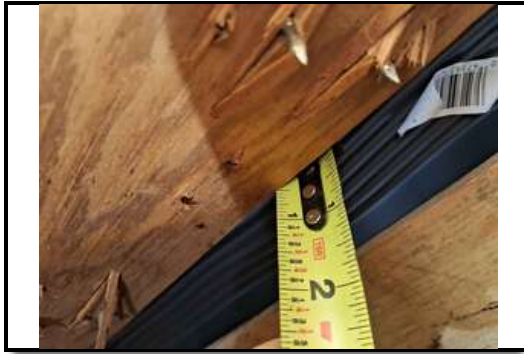
4. Roof Deck Attachment

- ☒ C. Plywood/OSB roof sheathing with a minimum thickness of 7/16" attached to the roof truss/rafter (spaced a maximum of 24" o.c.) by 8d common nails spaced a maximum of 6" in the field. **OR** Dimensional lumber/Tongue & Groove decking with a minimum of 2 nails per board (or 1 nail per board if each board is equal to or less than 6" in width). **OR** Any system of screws, nails, adhesives, other deck fastening system or truss/rafter spacing that is shown to have an equivalent or greater resistance than 8d common nails spaced a maximum of 6" in the field (max 24" truss/rafter spacing) or has a mean ultimate uplift resistance of at least 182 psf.

Roof Deck Attachment

The image consists of two side-by-side photographs showing the interior of a roof structure. Both photos show wooden joists and a wooden roof deck. In the left photo, a green measuring tape is stretched across the width of the joists. In the right photo, a yellow measuring tape is stretched across the width of the joists. A black object, possibly a piece of equipment or a bag, is visible in the foreground of the right photo.

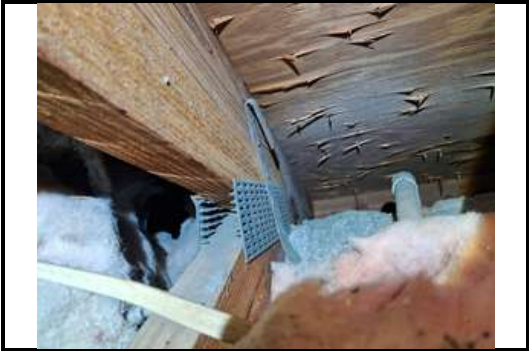
5. Roof to Wall Attachment

- ☒ B. Clips:
- ☒ Metal connectors that do not wrap over the truss/rafter, **OR**
  - ☐ Metal connectors with a minimum of one (1) strap that wraps over the truss/rafter and does not meet the nail position requirements of C or D but is secured with a minimum of three (3) nails, **OR**

Roof to Wall Attachment

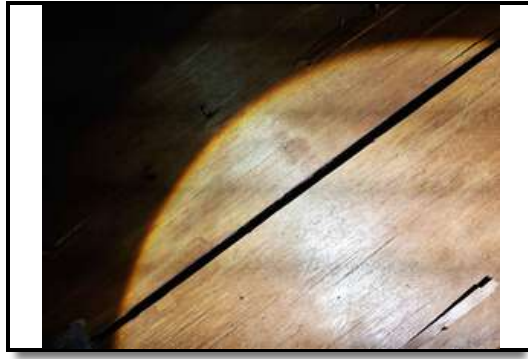
6. Sealed Roof Deck/Secondary Water Resistance (SWR)

- ☒ A. Sealed Roof Deck (also called SWR)
    - ☒ Fully adhered polymer-modified bitumen roofing underlayment complying with ASTM D1970.
    - ☐ Tape over roof deck seams with felt or synthetic. (A minimum 3.75-inch-wide (95 mm) strip of self-adhering polymer-modified bitumen membrane complying with ASTM D1970 or self-adhering flexible flashing tape complying with AAMA 711, Level 3 [for exposure up to 176°F (80°C)]).

Sealed Roof Deck/Secondary Water Resistance (SWR)
