## Uniform Mitigation Verification Inspection Form

| Owner Name: Village on the Green Condominium II Association Inc. | | Contact Person: Les Prest / Jennifer Noland |
| Address: Bldg # 2579 Bayberry Dr (Units A, B, C, D) | | Home Phone: |
| Year of Home: 1979 | # of Stories: 1 | Email: lessueprest@hotmail.com, |

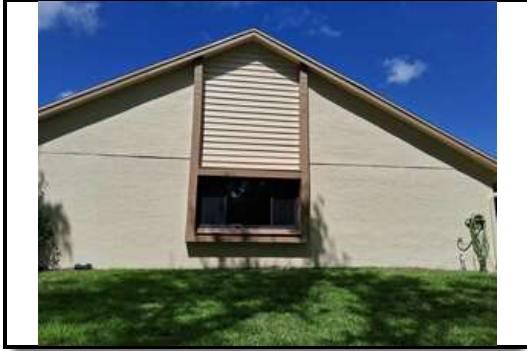
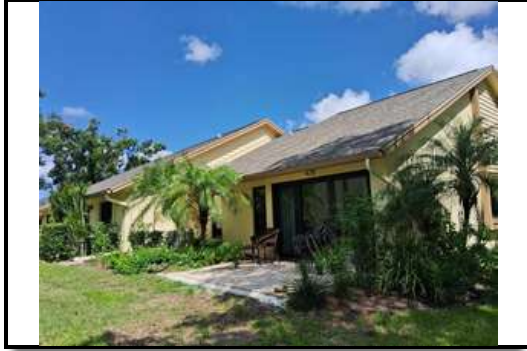
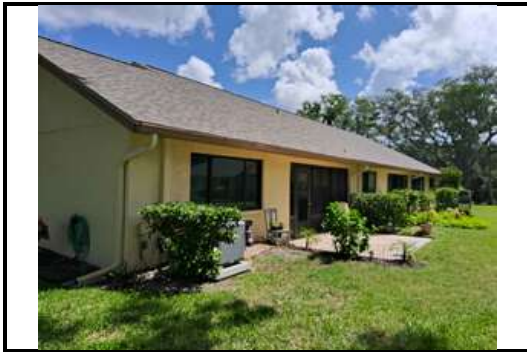
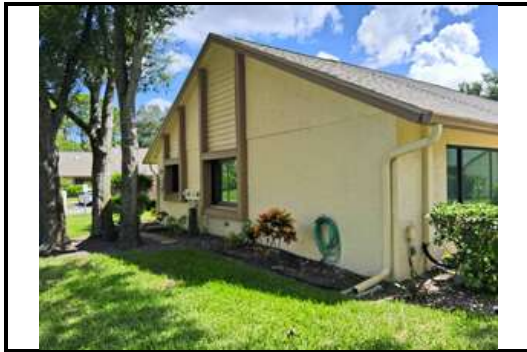
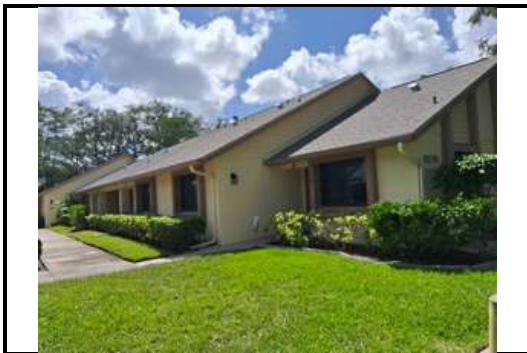
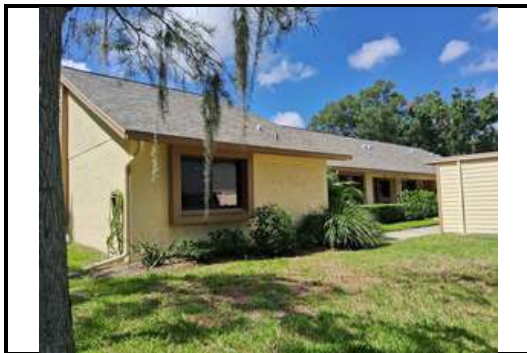
#### 1. Dwelling Elevations

Dwelling Elevations

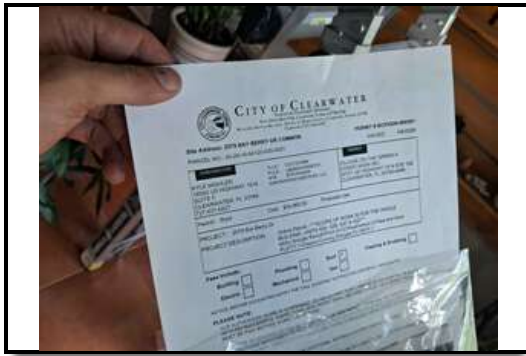
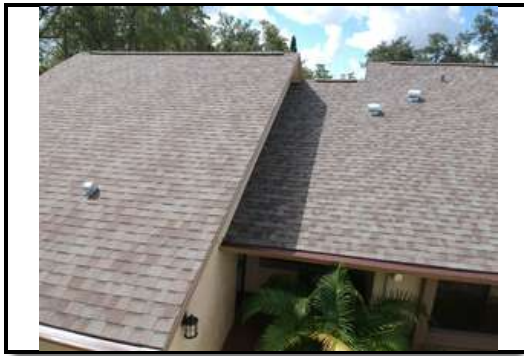
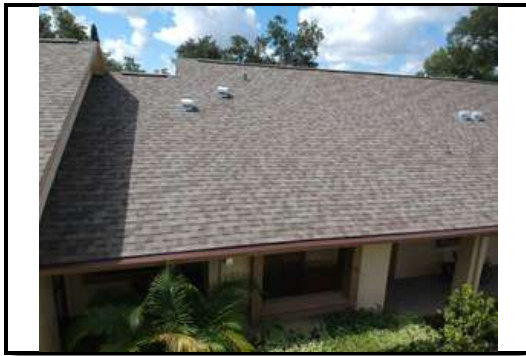
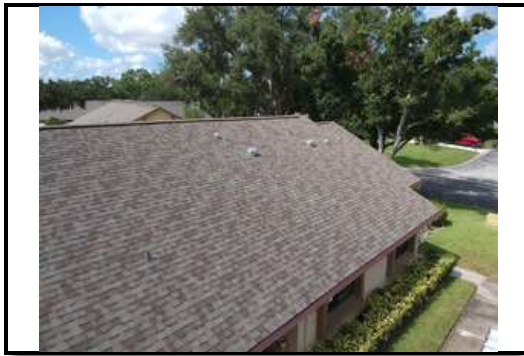
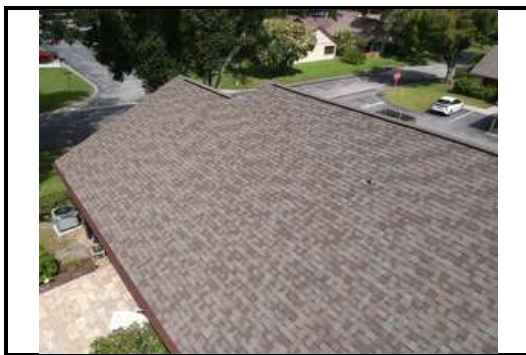
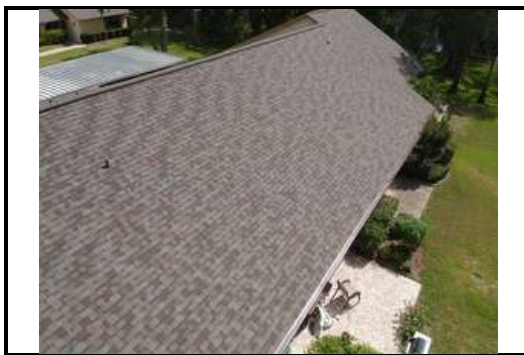
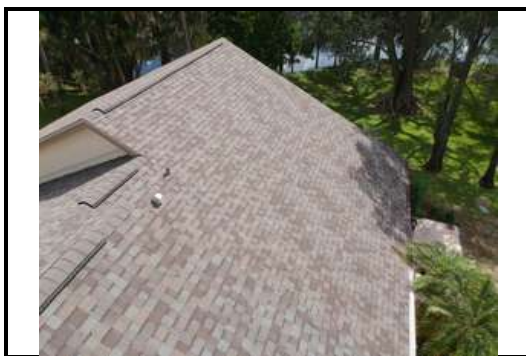
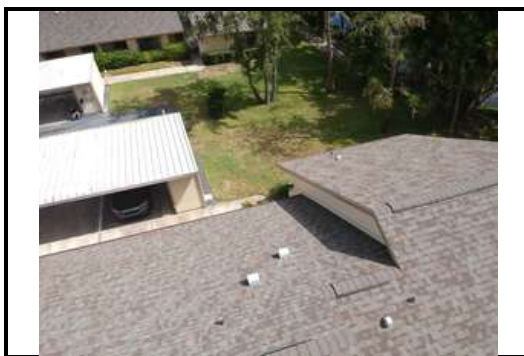
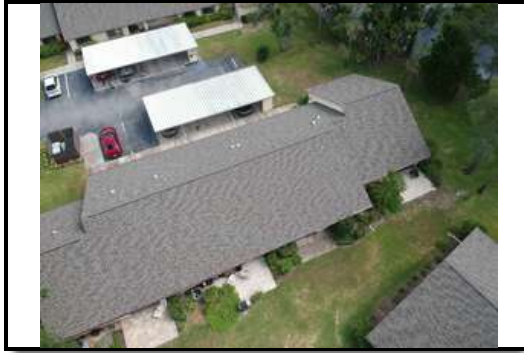
#### 2. Roof Slopes/Coverings

3. **Roof Slope:** For single-family homes with multiple slopes, indicate the slope that is at least two thirds of the main roof area when determining greater than or equal to 6:12, OR less than 6:12.
  - ☒ Greater than or equal to ( $\geq$  6:12)
  - ☐ Less than ( $<$  6:12)

| 4.1 Roof Covering Type | Permit Application Date | FBC or MDC Product Approval # | Year of Original Installation or Replacement | No Information Provided for Compliance |
|---|---|---|---|---|
| <input checked="" type="checkbox"/> Asphalt/Fiberglass Shingle | 6/8/2026 | | 2026 | <input type="checkbox"/> |

Roof Slopes/Coverings

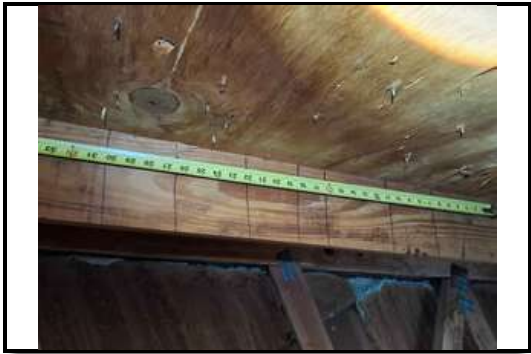
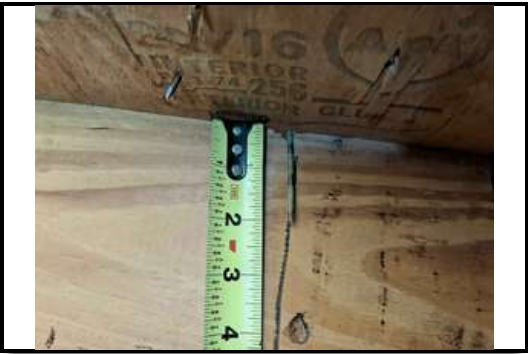
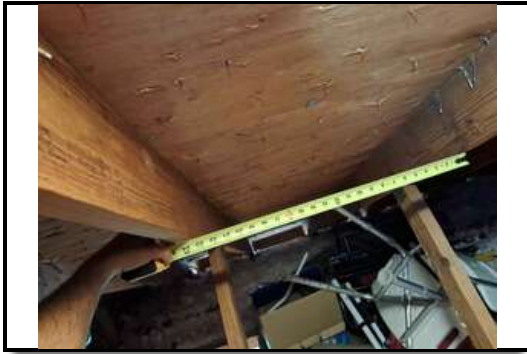
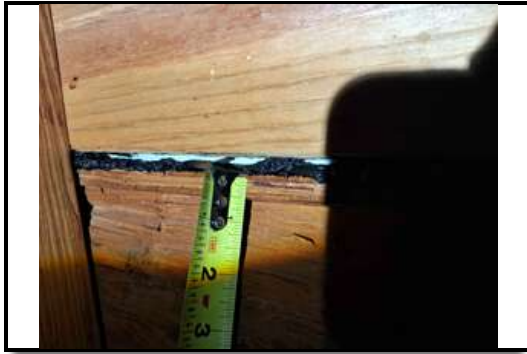
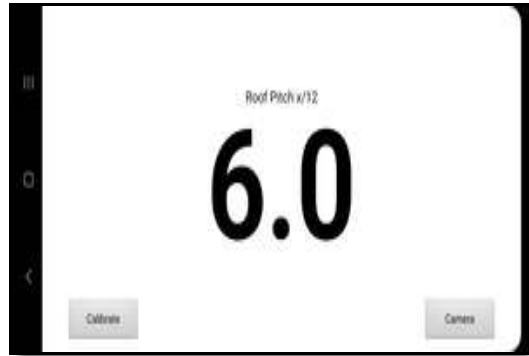
4. Roof Deck Attachment

- ☒ C. Plywood/OSB roof sheathing with a minimum thickness of 7/16" attached to the roof truss/rafter (spaced a maximum of 24" o.c.) by 8d common nails spaced a maximum of 6" in the field. **OR** Dimensional lumber/Tongue & Groove decking with a minimum of 2 nails per board (or 1 nail per board if each board is equal to or less than 6" in width). **OR** Any system of screws, nails, adhesives, other deck fastening system or truss/rafter spacing that is shown to have an equivalent or greater resistance than 8d common nails spaced a maximum of 6" in the field (max 24" truss/rafter spacing) or has a mean ultimate uplift resistance of at least 182 psf.

Roof Deck Attachment

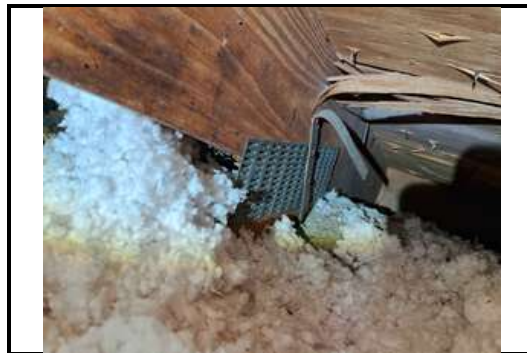
#### 5. Roof to Wall Attachment

- ☒ 1. Metal connectors secured to truss/rafter with a minimum of three (3) nails, and attached to the side and/or bottom of the wall framing top plate, or embedded into the bond beam, with less than 1/2" gap from the blocking or truss/rafter, and blocked no more than 1 1/2" from the truss/rafter, and free of visible severe corrosion, **OR**

- ☒ B. Clips:
- ☒ Metal connectors that do not wrap over the truss/rafter, **OR**
  - ☐ Metal connectors with a minimum of one (1) strap that wraps over the truss/rafter and does not meet the nail position requirements of C or D but is secured with a minimum of three (3) nails, **OR**

Roof to Wall Attachment
