## Uniform Mitigation Verification Inspection Form

| Address: Bldg # 2585 Bayberry Dr (Units A, B, C, D) | | Home Phone: |

#### 1. Dwelling Elevations

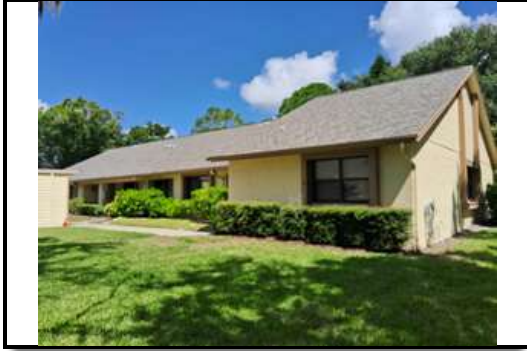
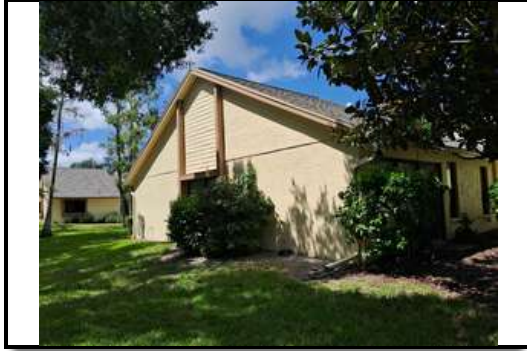
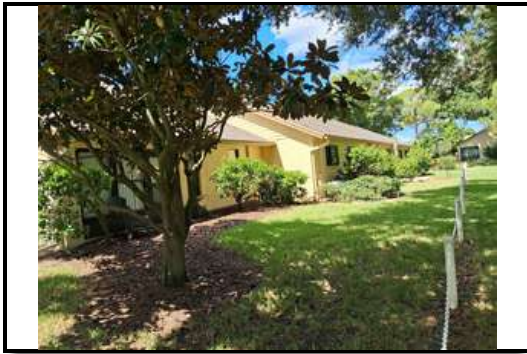
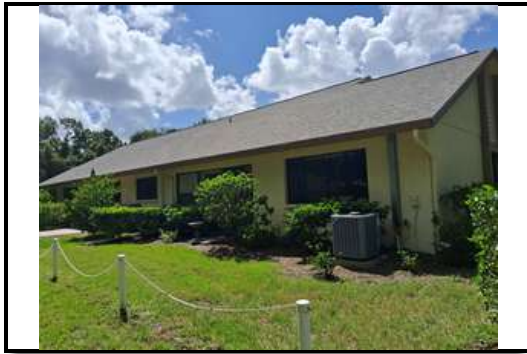
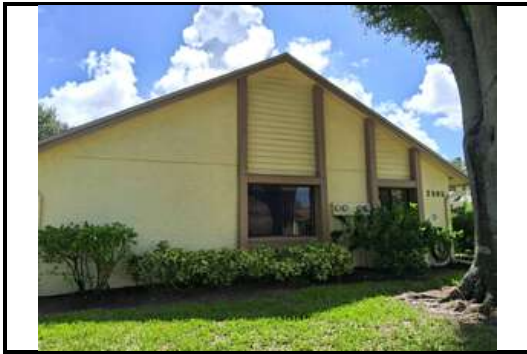
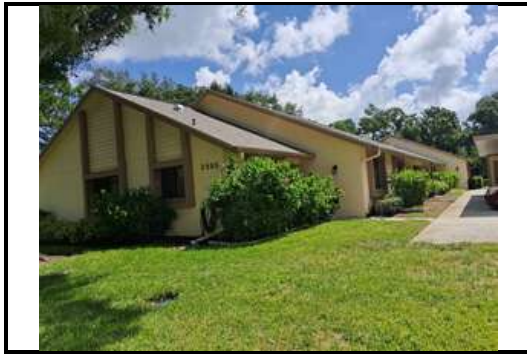
Dwelling Elevations

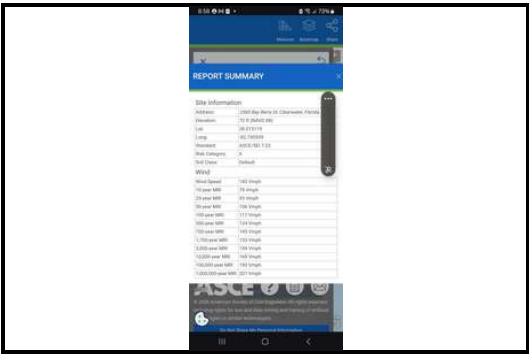
#### 2. Region

2. **Region:** Location based on design windspeed. See ASCE 7-22 (700-year MRI) Risk Category 2 (www.ascehazardtool.org).
  - ☐ HVHZ
  - ☒ Region 1 ( $\geq$  140 mph)
  - ☐ Region 2 (130 mph - 139 mph)
  - ☐ Region 3 ( $<$  130 mph)

Region ASCE 7-22 (700-year MRI) Risk Category 2 ([www.ascehazardtool.org](http://www.ascehazardtool.org)).

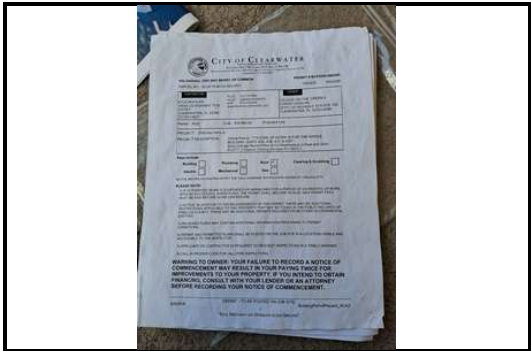
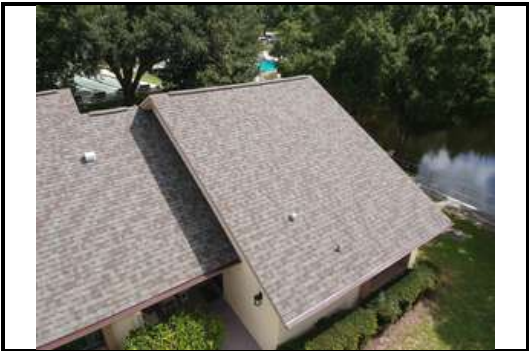
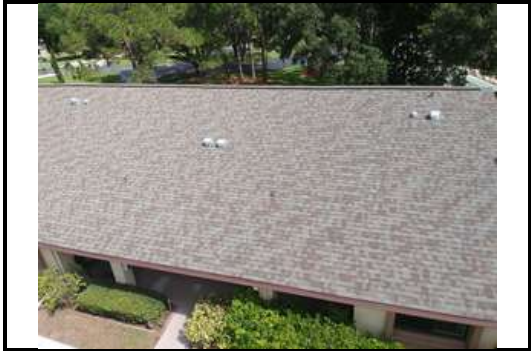
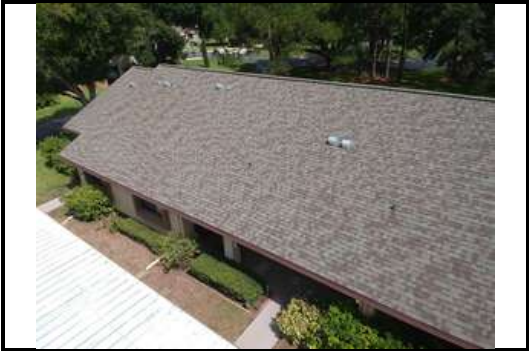
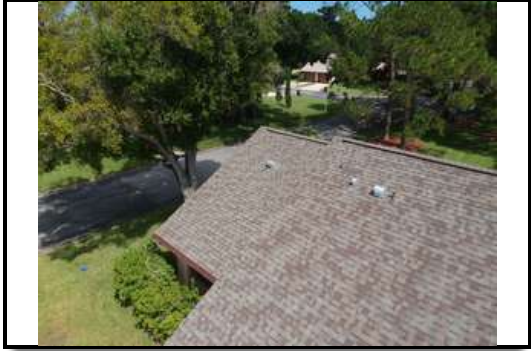
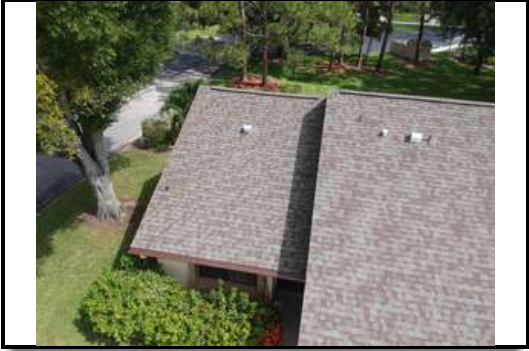
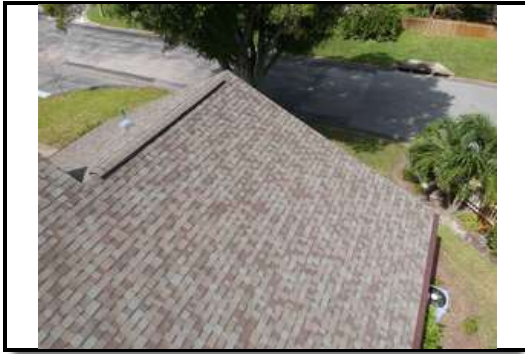
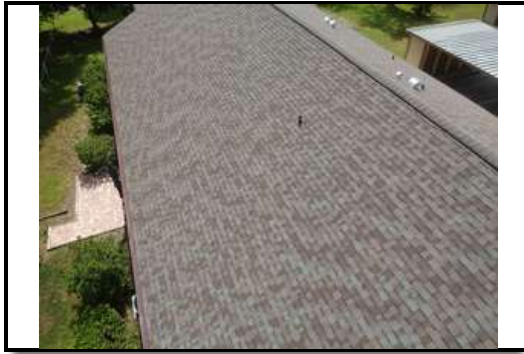
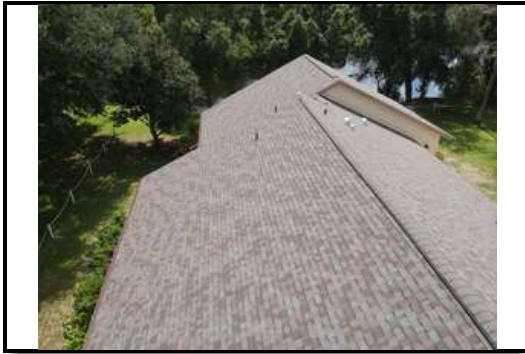
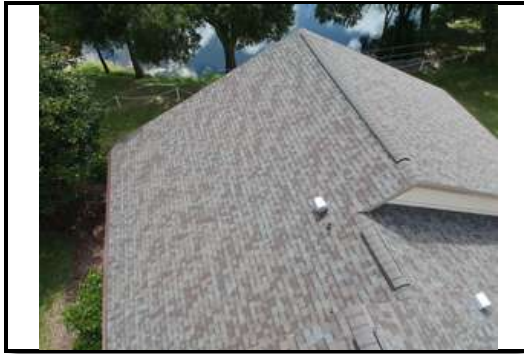
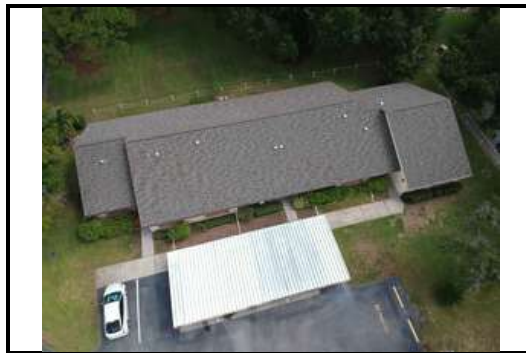
3. Roof Slopes/Coverings

3. **Roof Slope:** For single-family homes with multiple slopes, indicate the slope that is at least two thirds of the main roof area when determining greater than or equal to 6:12, OR less than 6:12.
  - ☒ Greater than or equal to ( $\geq$  6:12)
  - ☐ Less than ( $<$  6:12)

| 4.1 Roof Covering Type | Permit Application Date | FBC or MDC Product Approval # | Year of Original Installation or Replacement | No Information Provided for Compliance |
|---|---|---|---|---|
| <input checked="" type="checkbox"/> Asphalt/Fiberglass Shingle | 6/8/2026 | | 2026 | <input type="checkbox"/> |

Roof Slopes/Coverings

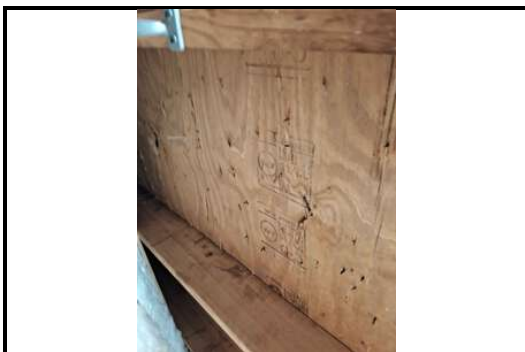
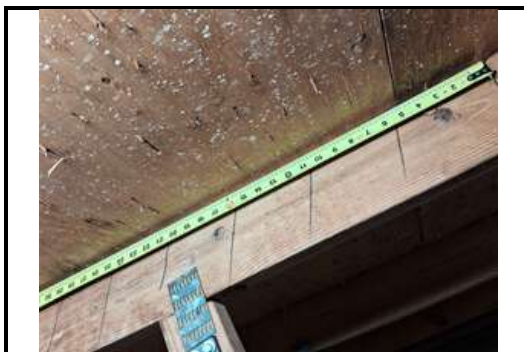
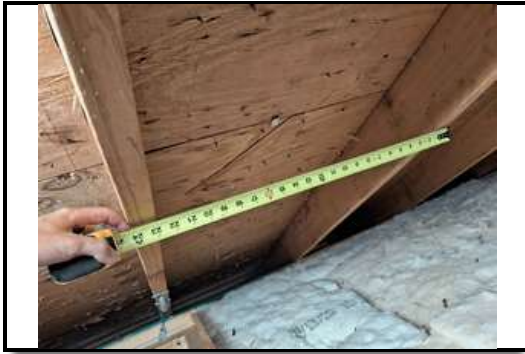
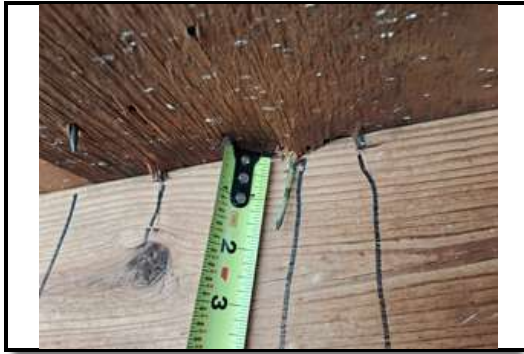
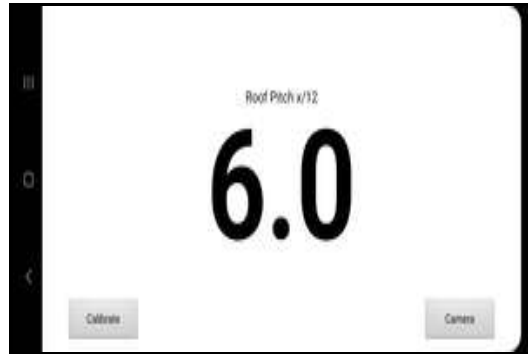
#### 4. Roof Deck Attachment

- ☒ C. Plywood/OSB roof sheathing with a minimum thickness of 7/16" attached to the roof truss/rafter (spaced a maximum of 24" o.c.) by 8d common nails spaced a maximum of 6" in the field. **OR** Dimensional lumber/Tongue & Groove decking with a minimum of 2 nails per board (or 1 nail per board if each board is equal to or less than 6" in width). **OR** Any system of screws, nails, adhesives, other deck fastening system or truss/rafter spacing that is shown to have an equivalent or greater resistance than 8d common nails spaced a maximum of 6" in the field (max 24" truss/rafter spacing) or has a mean ultimate uplift resistance of at least 182 psf.

##### Roof Deck Attachment

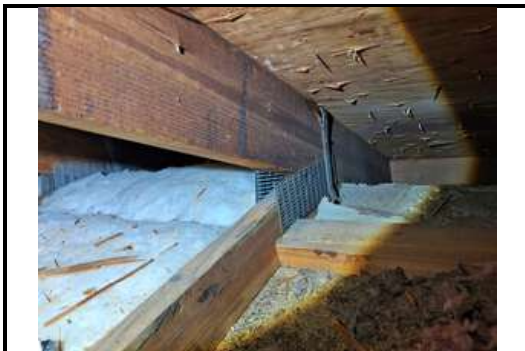
## 5. Roof to Wall Attachment

- ☒ A. Toenails:
  - ☐ Truss/rafter anchored to top plate of wall using nails driven at an angle through the truss/rafter and attached to the top plate of the wall, **OR**
  - ☒ Metal connectors or structural fasteners that are not installed as intended do not meet the minimal conditions or requirements of B, C, or D, **OR**
  - ☐ Other connection method documented to provide a substantiated wind allowable uplift capacity of 185 lbs. or greater.

2 nails

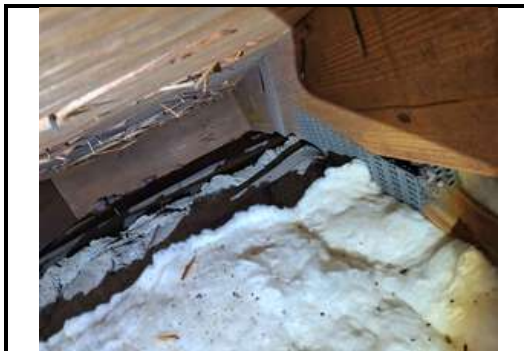
Strap not connected

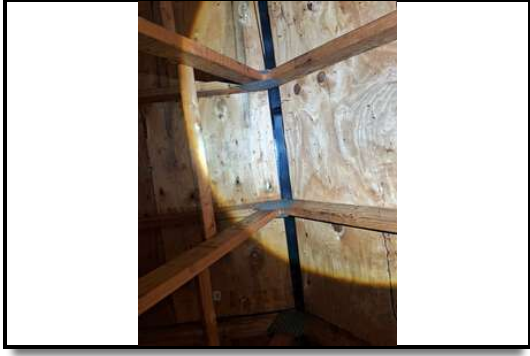
## 6. Sealed Roof Deck/Secondary Water Resistance (SWR)

- ☒ A. Sealed Roof Deck (also called SWR)
    - ☒ Fully adhered polymer-modified bitumen roofing underlayment complying with ASTM D1970.
    - ☐ Tape over roof deck seams with felt or synthetic. (A minimum 3.75-inch-wide (95 mm) strip of self-adhering polymer-modified bitumen membrane complying with ASTM D1970 or self-adhering flexible flashing tape complying with AAMA 711, Level 3 [for exposure up to 176°F (80°C)]).

Sealed Roof Deck/Secondary Water Resistance (SWR)
